Failure case of a garage door opener

K. Habib* and A. Al-Hazzaa*

Abstract

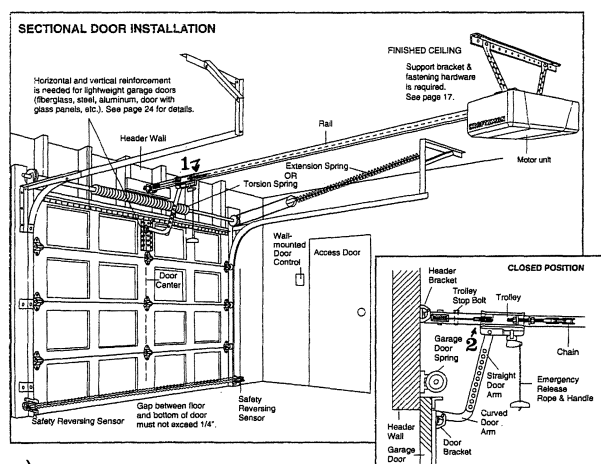
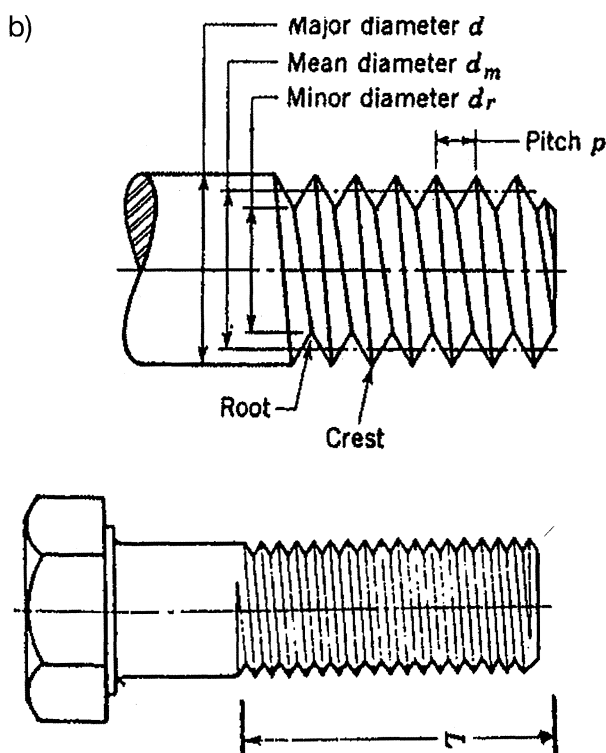
opener assembly and the broken bolt as items 1 and 2, respectively. Also, the schematic drawing shows, in figure 1b, the geometry of the connecting bolt. From figure 1b, it is most likely that the connecting bolt has gone through alternating tensional stresses first, because of the operational nature of the garage door-opener. Then, the connecting bolt has gone through torsional stresses due to a misalignment of the cable, between the connecting bolt and the trolley, later in time, before the failure occurred.

A visual inspection of the broken parts indicates that the broken bolt, see figure 1, has initially

Figure 1. a) A schematic drawing of the garage door, indicating the broken bolt location in the inner trolley of the garage door- opener assembly and the broken bolt as items 1 and 2, respectively. Also, the schematic drawing shows, in Figure 1b, the geometry of the connecting bolt.

suffered from a brittle fracture at and near the outer surface of the bolt, followed by an overloading, plastic deformation at the middle of the fracture surface. These findings are based on distinguished

features of the fracture surface of the bolts. The fracture surface was found to consist of two distinguished regions. One is a smooth and flat region, surrounding the outer surface of the bolt, in which multi-cracks had initiated and propagated in a brittle fashion. The other is a 45° inclined region, in the middle of the fracture surface, indicating the final rupture was due to a plastic deformation. In other words, many cracks were initially triggered from the surface of the bolt and propagated along a direction of 90° with respect to loading axis of the bolt, until the cross sectional area of the bolt was reduced to the point that the loading capability of the bolt was no longer able to handle the loading. As a result, rapid plastic deformation occurred along the plane of the maximum shear stress, in the middle of the fracture surface.

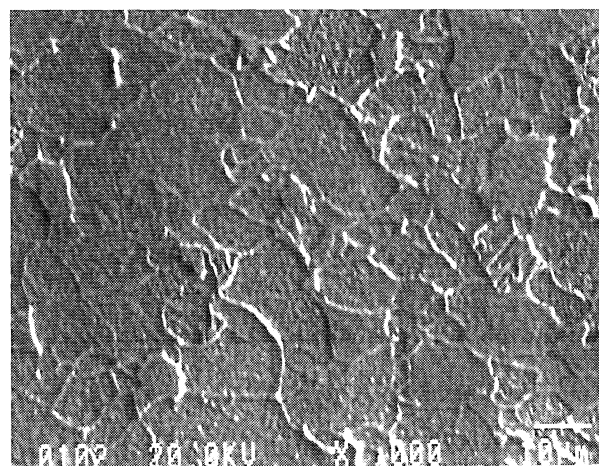
A quantitative WDS (wavelength dispersive spectroscopy), microanalysis revealed that the composition of the material of the connecting bolt is (weight %) 0.173 C, 0.76 Mn, 0.72 Cr, 0.17 Mo, 0.65 Ni, 0.2 Si, 0.09 P, 0.025 S and balance Fe. Accordingly, the material of the bolt is determined to be of a low alloying steel classified as a nickel, chromium, molybdenum low alloy steel. Also, the materials was found to have a hardness value around RB 59 (Rockwell hardness B scale), with ferritic and pearletic microstructures, see figure 2 for the microstructures of the broken bolt. From the literature^[1] this sort of material is typically used for relatively light transmission components.

Figure 2. The microstructures of the broken bolt.

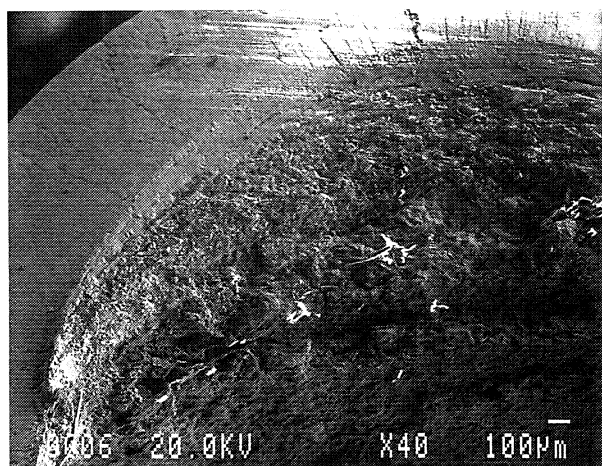
- Failure of the bolt initially occurred due to a consequence of multi-sites of crack nucleation from the bottom of the threads of the bolt along the circumference of the bolt, where the local stress concentration had exceeded the critical stress concentration. Figure 3 shows an example of multi-sites of the crack nucleation which emanated from the bottom of the threads along the circumference of the bolt. In addition, figure 3 shows a flat region next to the bottom of the threads a long the circumference of the bolt and a rough (inclined) region in the middle of the sample.

Figure 3. Multi-sites of the crack nucleation which emanated from the bottom of the threads along the circumference of the bolt. Also, Figure 3 shows a flat region next to the bottom of the threads a long the circumference of the bolts and a rough (inclined) region in the middle of the sample.

In the present failure case, we assume that the design of the bolt was safe to sustain fatigue damage however for one reason or another the bolt failed for unaccountable factors such as sharp stress concentration at the bottom of the bolt thread (see Fig. 3). Also, from the striation spacing in figure 4, one can determine the stress intensity factor range during the propagation region of the crack from a fracture mechanics approach. The striation spacing is defined as^[4]

calculated. Since the criterion for safe design from fracture mechanics that ΔK must be less than ΔK_{th} , where ΔK_{th} is the stress intensity factor range for the threshold of crack propagation. Consequently, this leads to the fact that during the cyclic loading of the bolt ΔK exceeded ΔK_{th} due to the presence of the stress concentration risers such as the one presented in figure 3, so eventually that led to the failure of the bolt.

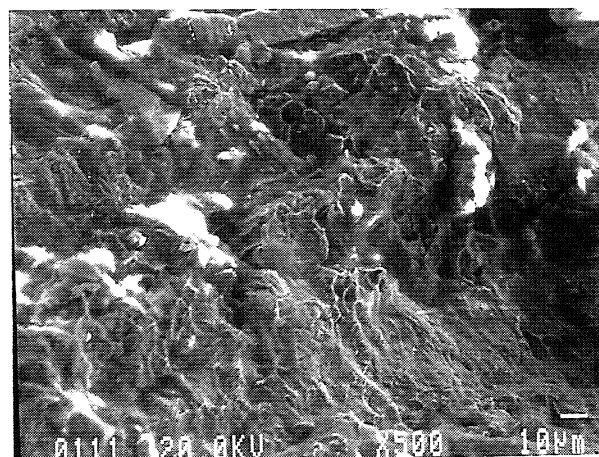
- SEM examinations revealed that the brittle failure of the bolt occurred due to fatigue damage phenomenon due to alternating torsional stresses. This finding is based on the documentation of fatigue striations along the direction of the crack propagation. Figure 4 is a fracture surface obtained from the flat and smooth area of the surface. It also exhibits fatigue striations along the crack propagation

Figure 4. SEM image of smooth and flat area of the fractured surface showing striations along the crack propagation direction. The striation spacing is nearly 14 µm.

path. The spacing between the striations is nearly 14 µm. This observation is in agreement with works published in literature elsewhere^[2]. In addition, figure 5 represents a fracture surface obtained from the incline region area in the middle of the surface. It is obvious that figure 5 exhibits a typical cup and cone of a ductile fracture, due to the over loading of the final failure of the bolt.

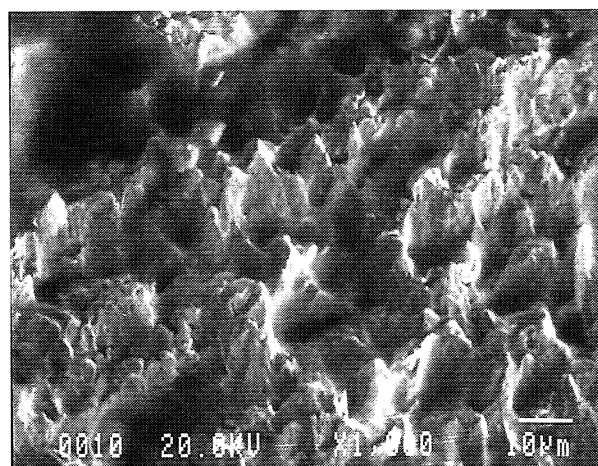
Figure 5. Represents a fracture surface obtained from the incline region in the middle of the surface. Figure 5 exhibits a typical cup and cone of a ductile fracture, due to the over loading of the final failure of the bolt.

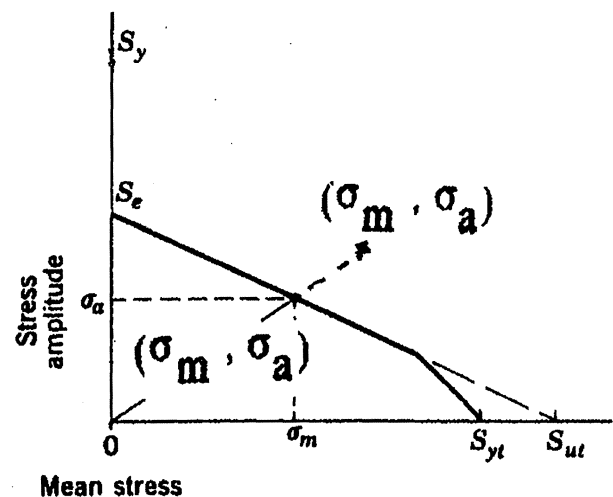
Therefore, a modified Goodman diagram can be plotted in which if the point (σ_a, σ_m) is found within the triangle $0 S_e \sigma_{ut}$, this leads to an infinite fatigue life (see Fig. 6). On the other hand, if the point is found outside the triangle, this leads to a finite fatigue life. As a result, the bolt is expected to fail within a certain number of cyclic loading.

Figure 6. A modified Goodman diagram showing finite and infinite fatigue life corresponding to the two positions of the point (σ_m, σ_a) .
