Stray current induced corrosion in lightning rod cables of 525 kV power lines towers: a case study

F.R. Wojcicki*, M.E.M. Negrisoni** and C.V. Franco***

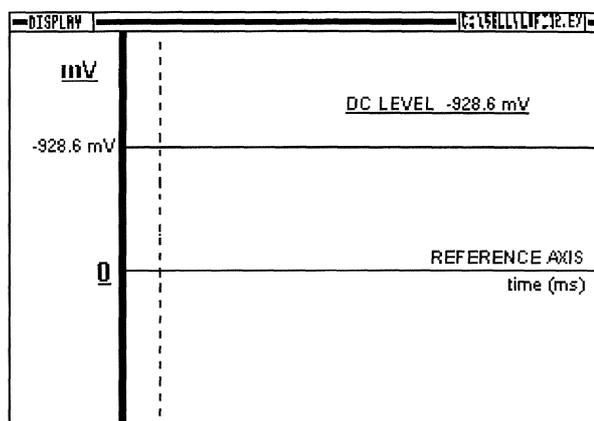
Figure 2. DC component measured with rods and tower disconnected.

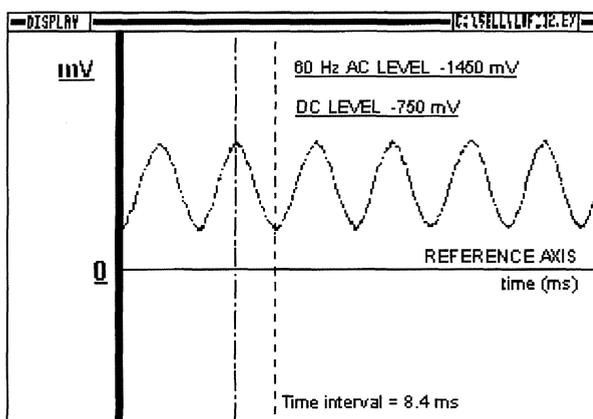
Figure 3. DC and AC components measured with rods and tower connected.

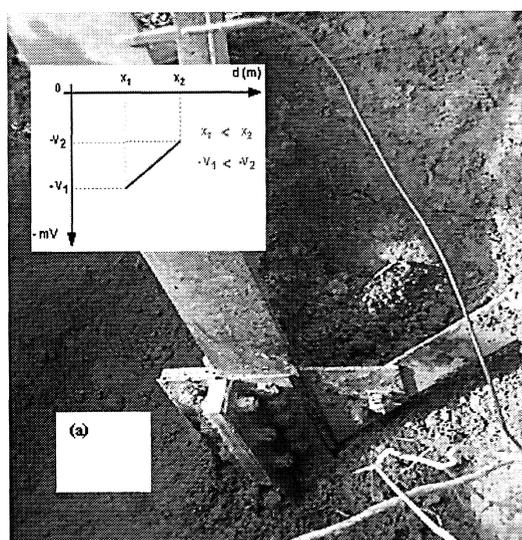
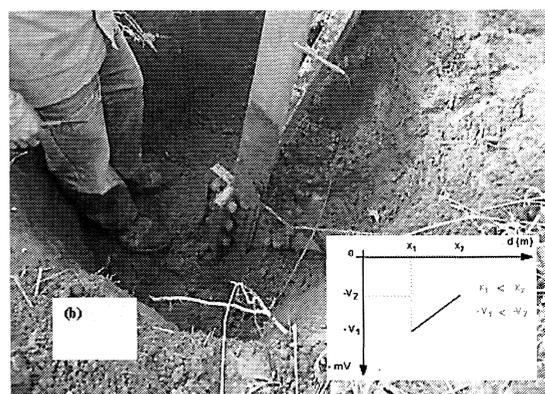
Table I summarizes the data obtained at the base of the 525 kV towers of ELETROSUL. The voltage is closely related to the flow of the stray current through the lightning rods of the line. Proof of that was obtained connecting the rods to the tower. They acted as current sources and intensified the corrosion process at the base of the towers. The values shown in table I were fitted to a straight line, as they fall in the linear region of the plot illustrated in figure 5. It can be seen that 82.40 % of the tests carried out at the base of the towers resulted in $\Delta V_1 < \Delta V_2$. Plots having a positive slope ($a = \tan \alpha$) were associated with anodic towers. The corresponding foundations were visually inspected in an attempt to assess the situation of the corrosion process. As it can be seen from figure 6 (a) and (b), the foundations showed evidence of extensive corrosion. The influence of the stray current flowing in those foundations was verified measuring the voltage at the base of anodic towers in advanced stage of corrosive degradation (Fig.6)^[7].

Figure 6. Images of anodically polarized foundation.

between adjacent spans is closed, the currents flow between towers in an electrochemical process. The counter-part of such currents is the stray current, which speeds up the corrosive process of anodically polarized towers. The effect of the stray current can be significantly reduced insulating the lightning-rod cables. Studies are still under way to verify the effect of the stray current on the resting electrode potential in an attempt to determine the conditions that lead to either anodic or cathodic processes at the tower foundation.

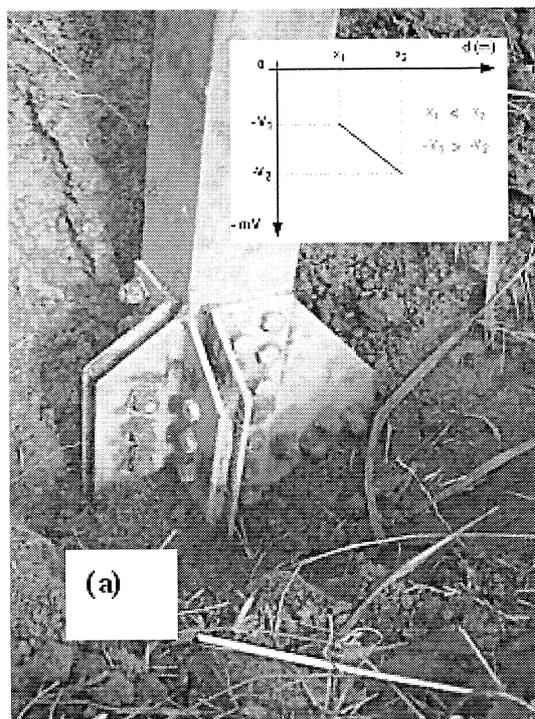
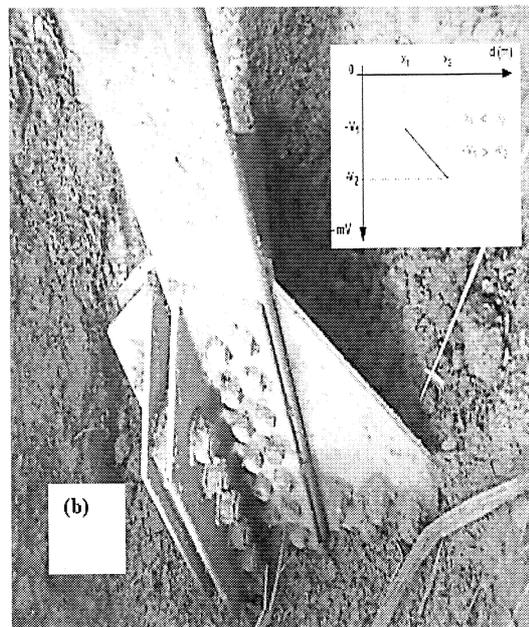
Conversely, plots with negative slope ($-a = \tan \alpha$) suggested a cathodic process-taking place at the foundations. Such towers were also visually inspected, but no signs of corrosion could be detected. Figure 7 (a) and (b) show an example of a well-preserved structure corresponding to a cathodic tower.

Figure 7. Images of a cathodically polarized foundation.
