Pitting corrosion in austenitic stainless steel water tanks of hotel trains⁽¹⁾

D.A. Moreno*, A. M. García*, C. Ranninger* and B. Molina**

The water storage tanks of hotel trains suffered pitting corrosion. To identify the cause, the tanks were subjected to a detailed metallographic study and the chemical composition of the austenitic stainless steels used in their construction was determined. Both the tank water and the corrosion products were further examined by physicochemical and microbiological testing. Corrosion was shown to be related to an incompatibility between the chloride content of the water and the base and filler metals of the tanks. These findings formed the basis of recommendations aimed at the prevention and control of corrosion in such tanks.

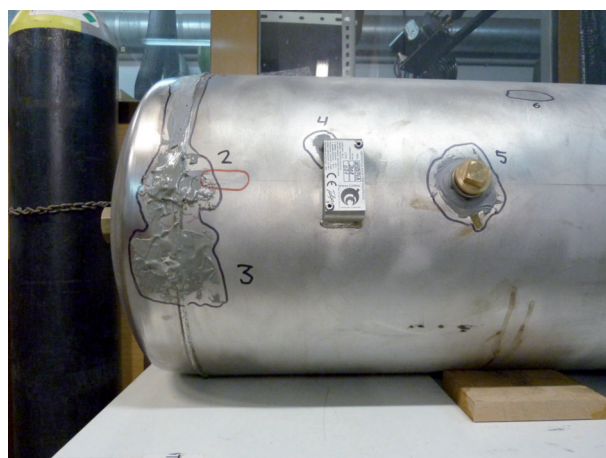
Water tanks removed from hotel train 7C9 due to pitting corrosion problems were visually inspected at the Patentes Talgo plant in Rivabellosa (Álava, Spain). The cylindrical tanks have torispherical heads and in service are placed in a horizontal position. One 250-L tank, removed from a shower car in the last train built in 2008, was chosen for the study. The tanks showed signs of pitting corrosion only a few months after it had been put into service as well as

evidence of several subsequent repairs (Fig. 1). All the repairs involved the tank's lower zone, where most of the nozzles were located. The tank's upper zone was not corroded (Fig. 2).

Figure 1. Aspect of the 250-L water tank around the lower zone (head 1). The repairs, made with resin, are seen.

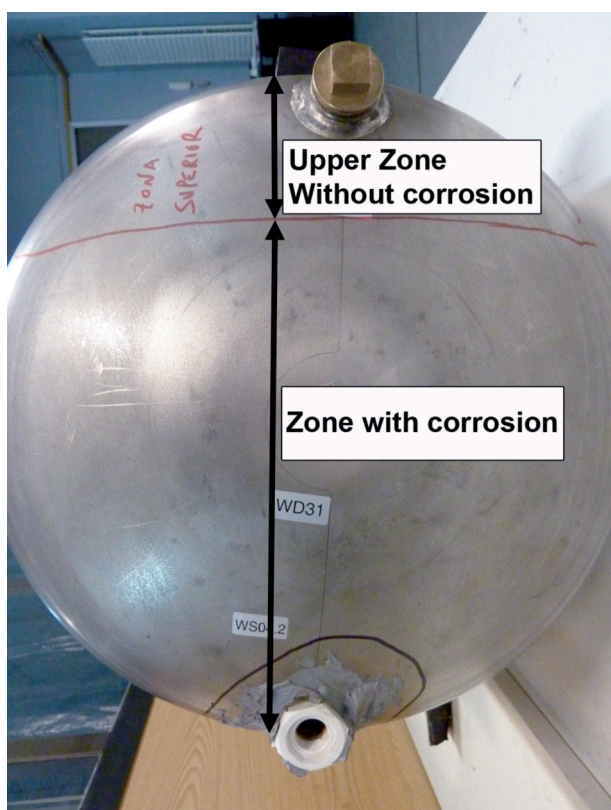
Figure 2. View of head 2 of the 250-L water tank, with corrosion and non-corrosion zones indicated.

Corrosion was limited to the area between the base metal and the weld metal. Of the 12 points of corrosion detected, five were located in the nozzles, five at the circumferential seams, and two at the longitudinal weld seams. The circumferential seams of the tank's head to shell welds were the most extensively affected and thus probably the first to suffer corrosion.

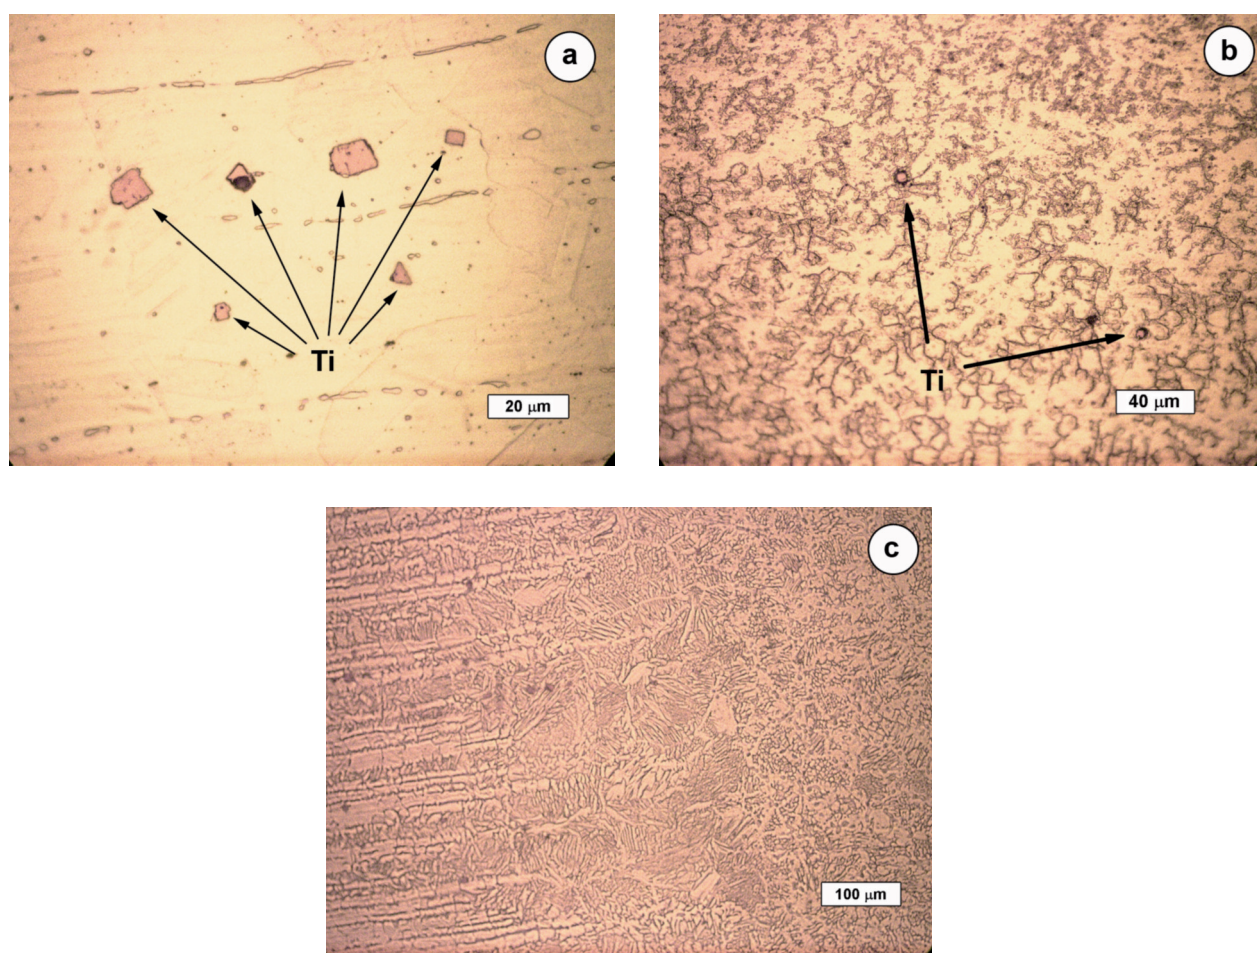
crystals were clearly distinguished by their pink colour and in some zones were aligned with the bands (Fig. 3a)). This material, from a metallographic point of view, has a microstructure consistent with its composition.

The weld metal had a dendritic structure with titanium crystals in its matrix (Fig. 3b)). The weld-metal zone close to the base metal showed a Widmanstätten microstructure, with embedded titanium crystals coming from the base metal (Fig. 3c)) since the filler metal, identified as niobium (Nb)-stabilized stainless steel ER347, lacks titanium (Ti) in its composition (Table II). The filler metal was ER347, which contains Nb and complies with the specifications of Patentes Talgo. The Ti crystals observed in the weld pool were smaller than those of the base metal and reflected the dilution of the filler metal during the welding process.

The $\delta+\gamma$ microstructure in the weld with ER347 as filler metal indicated the use during welding of a high heat input and a low cooling rate^[10].

Figure 3. Microstructure of the stainless steel used to manufacture the 250-L water tank; a) Titanium crystals aligned according to lamination bands in the base material; b) Weld metal with titanium crystals visible in its matrix; c) Weld-metal zone close to the base metal showed a Widmanstätten microstructure.

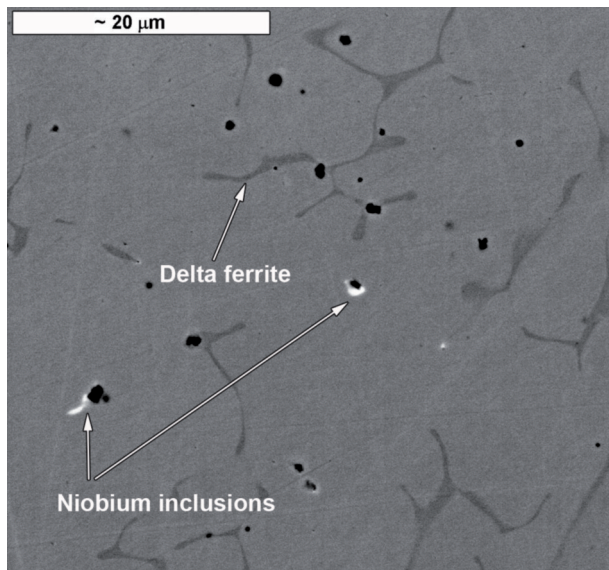
The metallographic study was completed with a detailed scanning electron microscopy analysis using X-ray dispersive energy. This was accomplished by a 3,500 - 5,000 \times magnification of the diverse phases observed in the microstructures. The weld metal thus observed showed an austenitic matrix containing islands of delta ferrite and Nb inclusions (Fig. 4).

The ferrite in the weld metal was found to have a typical Cr content. The ratio with Nb particles (Nb/Fe) was 0.92 versus a weight-based stoichiometric ratio in the Lewis phase (Fe_2Nb) of 0.83. The 10 % difference was reasonable.

Figure 4. Austenitic matrix containing islands of delta ferrite and niobium inclusions in the weld metal. Image obtained using scanning electron microscopy with back-scattering electron (2,000x).

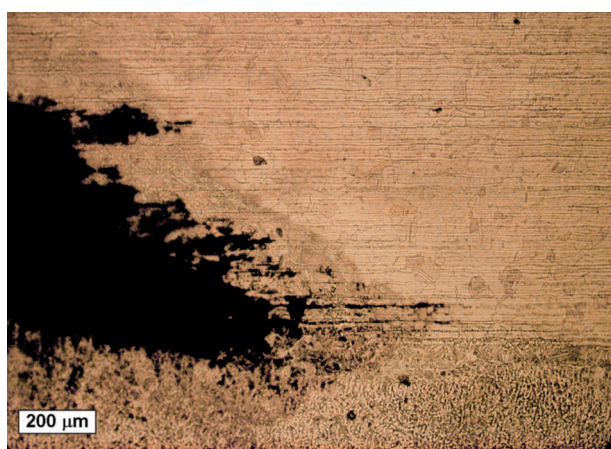
In the longitudinal weld seam extending from the head to the central circumferential weld seam, unrepaired pitting, denoted as F - 41, was observed and subjected to further analysis. On the outer part of the tank, the water and the corrosion products had obviously drained through the pitting zone and down the tank. The pitting zone was located between the base metal and the weld metal. By partially removing the oxides on the inside, we observed two adjacent pitting zones. Areas in which the pitting had been repaired consistently showed a large agglomeration of micropitting, always located between the base metal and the weld metal and preceding the occurrence of pitting.

For the metallographic study, a series of cuts were made in the original test material to obtain specimens of the appropriate size for study. These were polished and then subjected to electrolytic etching. Optical microscopy showed that pitting had occurred completely within the weld seam, forming a line along the HAZ and barely entering the base metal through the lamination bands (Fig. 5). However, the corrosion then rapidly progressed towards the inside of the weld seam by following its dendritic structure (the interface between delta ferrite and austenite) (Fig. 6).

Figure 5. Pitting corrosion on the base-metal side. The corrosion has progressed along the lamination bands of the base metal.

Corrosion therefore initiated between the base metal and the weld metal, that is, in the HAZ, and progressed rapidly to the welding zone, which acted anodically, but it also involved the base metal, albeit more slowly.

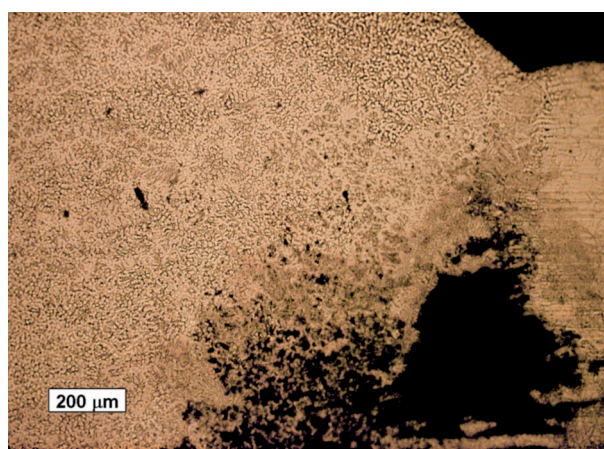
Figure 6. Pitting corrosion on the weld-metal side. The corrosion has progressed along the dendritic phase of the weld.

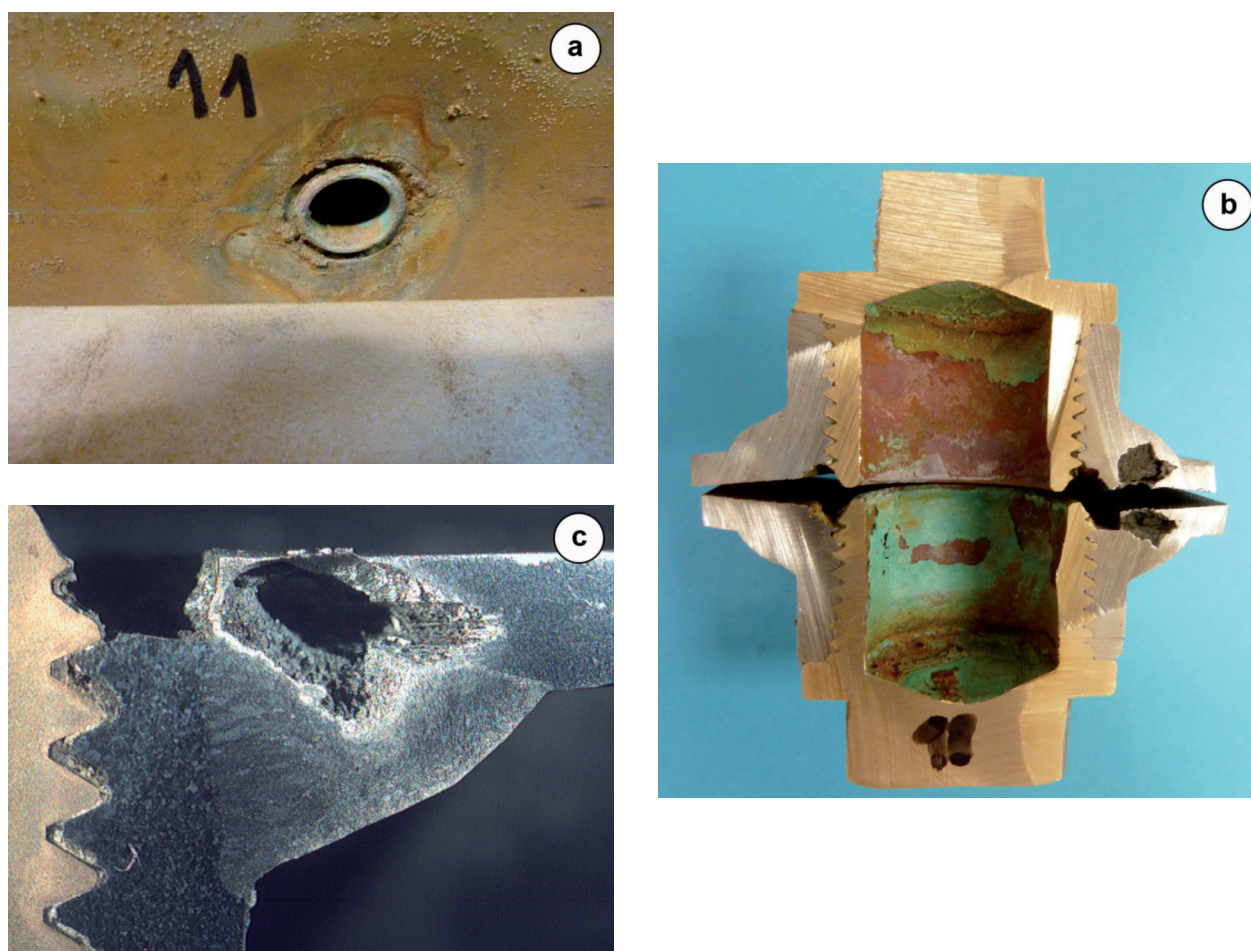
The interior of the corrosion site F - 11 is shown in figure 7a). F - 11 corresponds to a nozzle made of AISI 316 and was located in the lower zone of the tank. The nozzle was not welded on the inside and none of the welds between the nozzles and the shell plate had been made from the inside. Moreover, most of the nozzles, including the one involving F-11, were blind, with bronze plug pipes.

Observation of the F - 11 nozzle from the inside showed two small pitting on the external zone, where the weld metal and base metal met, which had been repaired. Cutting the nozzle in half revealed that the join between the shell plate and the nozzle had almost completely disappeared due to extensive subsurface pitting. The resulting pits had filled with corrosion products (Fig. 7b) and 7c)).

Electrolytic etching of the polished test specimen showed that in the two pitting zones detected on the inside of the water tank, corrosion ran along the edge of the welding, progressing toward the interior but hardly towards the tank's base metal (Fig. 7c)). In no case did the corrosion involve nozzle material made of AISI 316. As noted above, this was due to the fact that AISI 316 contains Mo, which makes it resistant to pitting corrosion. The influence of alloyed Mo in

Figure 7. a) Interior of the F-11 specimen obtained from the 250-L water tank, corresponding to a nozzle welded only on the outside and fitted with a bronze plug pipe; b) Nozzle cut in two sections; c) Enlargement of b), showing subsurface pitting almost completely occupying the weld section.
