Failure analysis of copper pipes used in the heat exchangers in fan coil units

ABSTRACT: Heat exchangers (HE) consist of copper and steel pipes and are used for heating and cooling the ambient air. One of the main problems seen in HE is the leakage on copper pipes. In this study, failed and properly working copper pipe samples used for different durations were examined in detail. The microstructural analyses were performed using optical microscopy (OM) and scanning electron microscopy (SEM) to detect corrosion occurrences on copper pipe surfaces. In addition, corrosion products of the samples were defined by X-Ray Diffraction (XRD), Energy Dispersive Spectroscopy (EDS) and Fourier-Transform Infrared Spectroscopy (FTIR) analyses. The formation of interconnected tunnels in cross section of the failed copper pipe sample that were in microscopic dimensions and corrosion products were observed. Consequently, all the analyses result that were obtained from the samples pointed out a corrosion mechanism known as ant-nest corrosion. It was concluded that the main reason of corrosion was related to ethylene glycol type additives which were used in HE along with mains water.

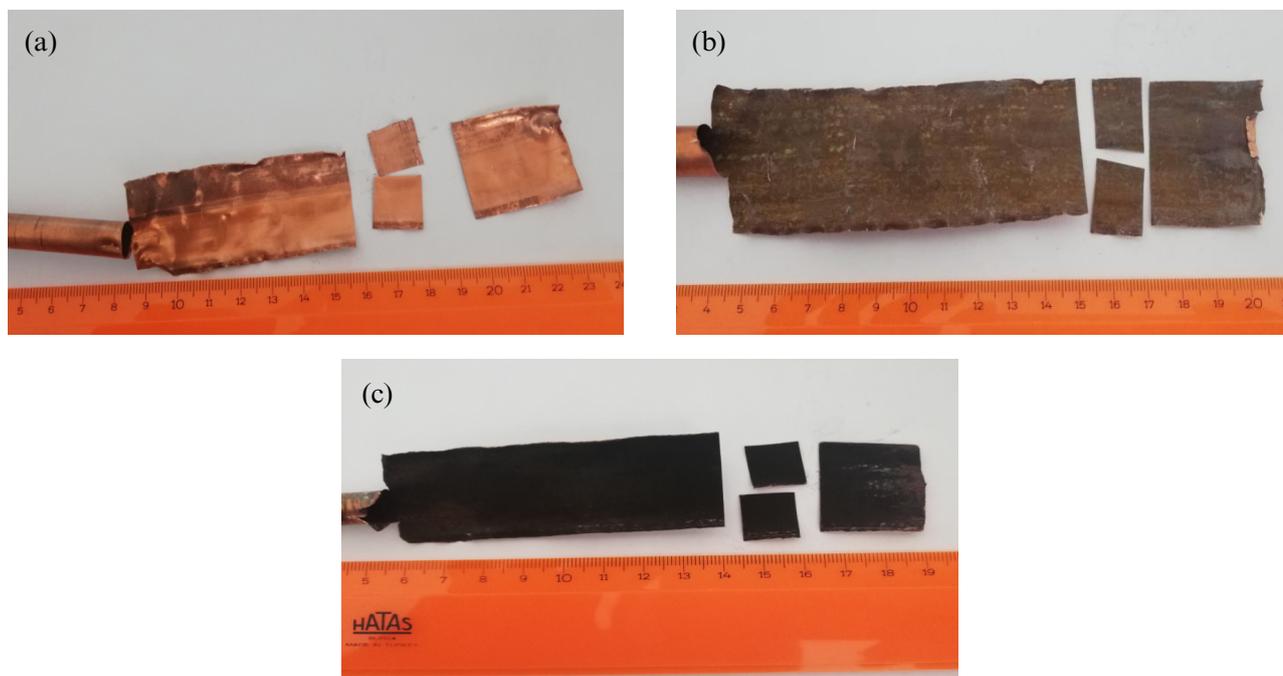
siderable difference between failed and proper working pipes was present of black corrosion product inner surface of C3 sample. Figure 1 shows the images of copper pipe samples just before they were cut for the analyses and cold molding for microstructural examination. Subsequently, the grinding and polishing processes were done respectively, and the samples were made ready for metallographic examination. The morphology of copper pipe samples was examined with optical microscope (OM) (Nikon LV 100) and SEM (Zeiss Gemini SEM 500) devices. The phases (in corrosion products and in the copper pipe samples) were identified by XRD analyses which were carried out with a sample rotation range of 0 to 80 2 θ degrees using CuK α radiation ($\lambda=1.5405$ Å). The spot and areal type EDS analyses were performed to investigate the elements in the samples using Zeiss Gemini SEM 500 device with an EDS detector. In addition, FTIR spectroscopy was performed to evaluate the functional groups (C-Cl) on the corrosion products of C3 sample. Corrosion products on the inner surface of the C3 sample were carefully scraped from the copper tube for performing this analysis. The existence of different structures other than oxide structures was investigated by examining the corrosion products in powder form.

FIGURE 1. a) 2 months used sample (C1) b) 2 years used sample (C2) c) 2 years used sample with black corrosion product covered surface and leakage problem (C3)

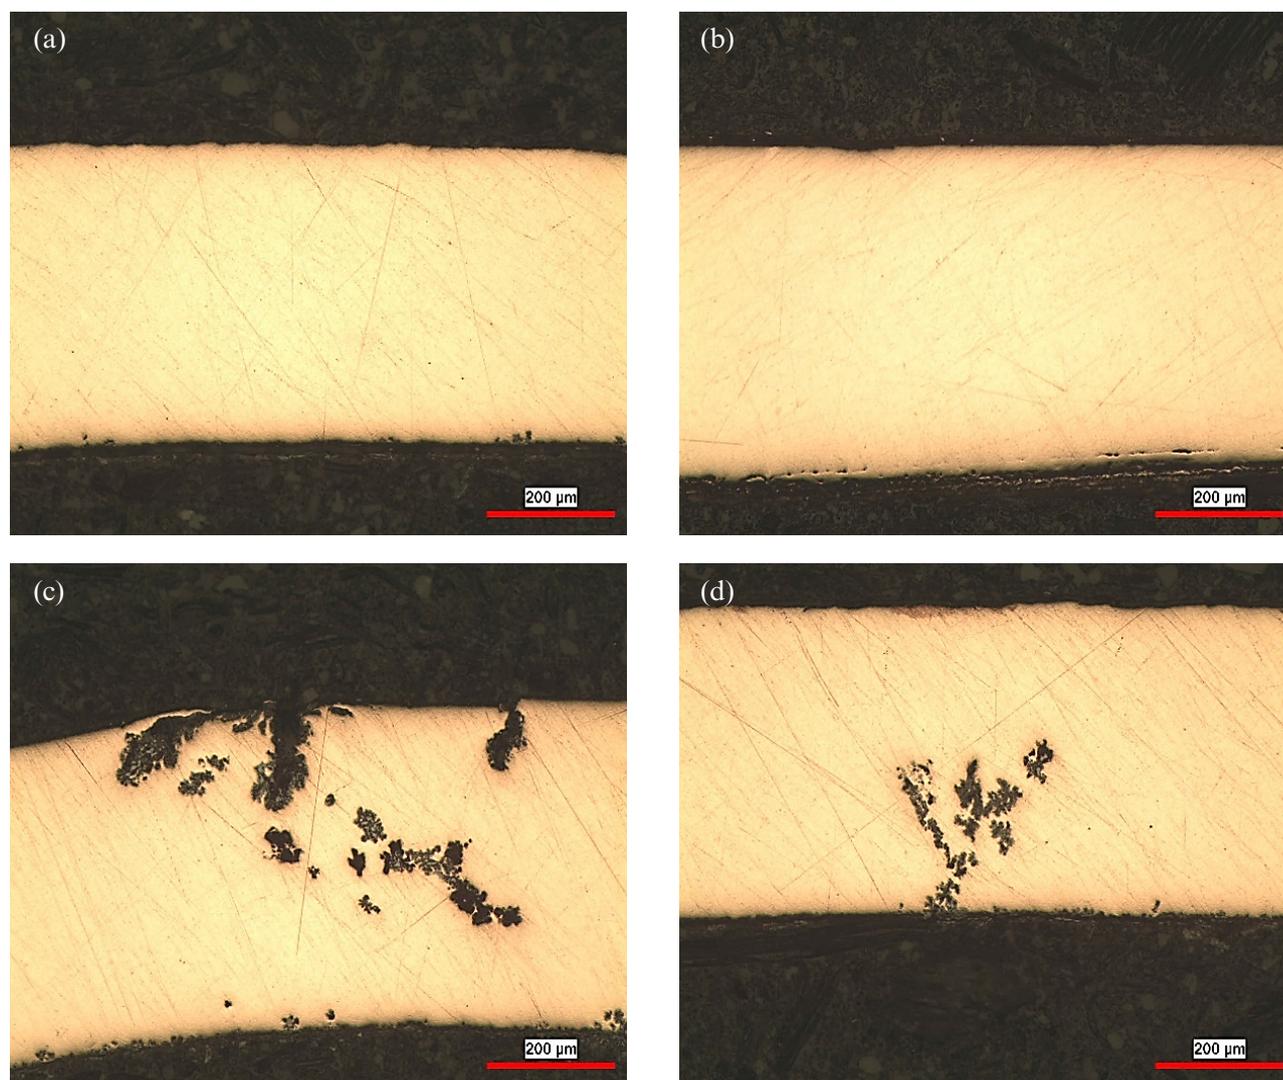
When all the samples were examined by naked eye, there was no clear failure on the sample surfaces. Thus, all samples' cross sections were examined by optical microscope in order to observe and find evidence for the possible corrosion and failure modes. Figure 2 shows the images of both failed and defect free copper pipe cross sections. It can be seen that there are no cracks or micro tunnel formations in the C1 and C2 samples. On the other hand, tunnel-like formations and defects were discovered in the C3 sample. When the working conditions and the failure type of the C3 sample considered, tunnel formations could be evaluated as the main reason of leakage. Since there was no visible corrosion damage on the sample inner surface and the material was operating in a fluid-liquid environment at 70-80 °C, it was determined that the corrosion in the C3 sample was similar to ant-nest corrosion (formicary corrosion). Ant-nest type corrosion occurs on the surface

of the copper pipe in the form of very fine pin-hole-like leaks that are not visible to the human eye. When examined under a microscope, ant-nest type corrosion pits show a tunnel structure connected to each other along the copper pipe (Moss, 1969; Pelto and Lindgren, 2015). In addition studies in the literature showed copper pipes that were exposed to formic acid and similar corrosive environments resulted with tunnel structure and failed because of ant nest corrosion (Situmorang and Kawai, 2018; Zhou *et al.*, 2018; Cozzarini *et al.*, 2020).

FIGURE 2. Optical microscopy images of copper pipe cross sections a) C1, b) C2, c) and d) C3 samples.

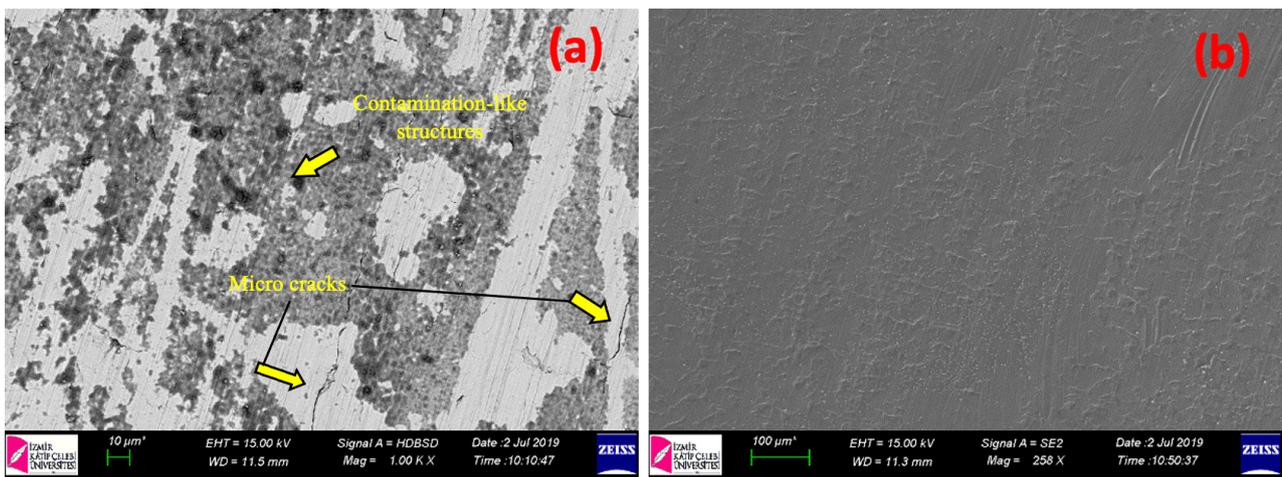
Figure 3 and Fig. 5 shows SEM images of C1, C2 and C3 samples, respectively. When the images of the C1 sample were examined, micro cracks and contamination-like structures were observed in various regions of the sample surface (indicated by

arrows). The presence of two structures was considered as a result of SEM analysis in Fig. 3a. When the C2 sample was examined by naked eye, a dark brown structure was seen easily on the surface of the sample. In Fig. 4, it was seen that dust-like structures deposited on the sample surface with different ratios in the different regions on the sample surface. In addition, microcrack formation which thought to be related to bending stresses applied during sample preparation process was observed at various regions in both C1 and C2 sample. SEM images of the C3 sample in Fig. 5 showed that the inner surface of the sample was apparently covered with a black corrosion product. It was observed that the amount of corrosion product accumulated on the surface was much higher than C2 sample. Also, the amount of corrosion product deposition on the surface showed regional differences and there were various microcracks and large cavities on the surface of these. In addition, it was thought that different structures exist due to contrast differences in Fig. 5a. According

FIGURE 3. a) SEM-BSD and b) SEM-SE images of C1 sample inner surface.

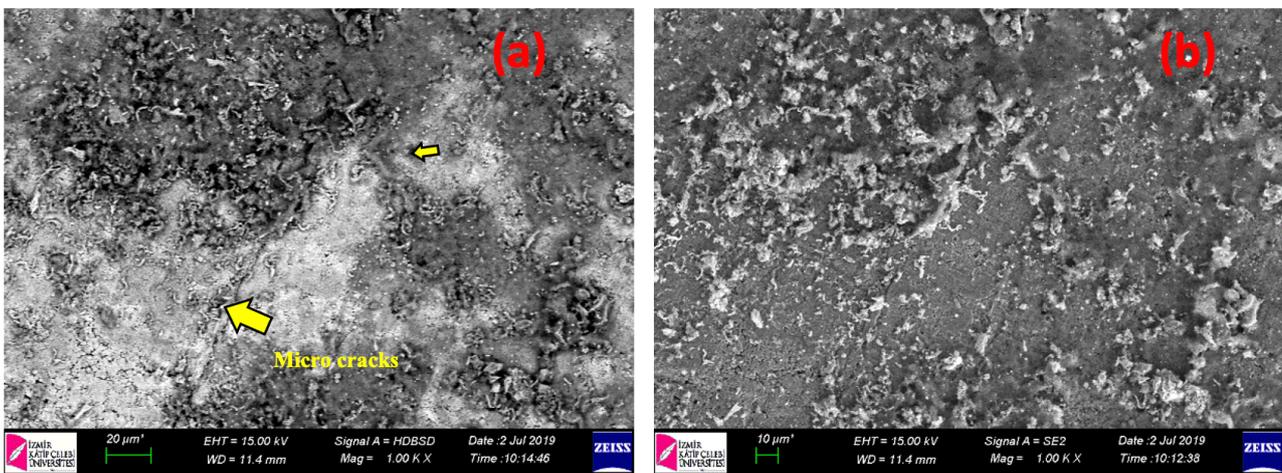
FIGURE 4. a) SEM-BSD and b) SEM-SE images of C2 sample inner surface.

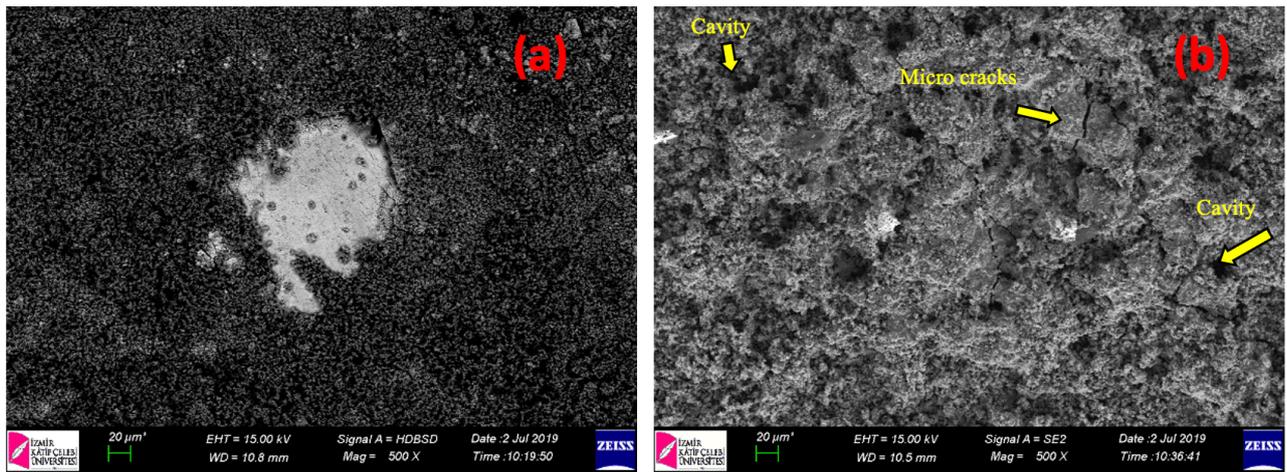
FIGURE 5. a) SEM-BSD and b) SEM-SE images of C3 sample inner surface covered corrosion products.

similar to ant-nest corrosion were observed. As can be seen in Fig. 5, an accumulated layer was formed on top of these pits. The fact that this accumulated layer was different in color (black) from the copper pipe in the SEM-BSD analysis was shown in Fig. 5a. This color difference indicates the presence of a different structure. In addition, crystal structures were seen around the corrosion hole in SEM images. Similar structures have been specified as copper oxide structures, which are specified as corrosion products in various studies (Peltola and Lindgren, 2015; Vazdirvanidis *et al.*, 2019). It has been stated that these structures were related to the ant-nest corrosion starting point (Peltola and Lindgren, 2015).

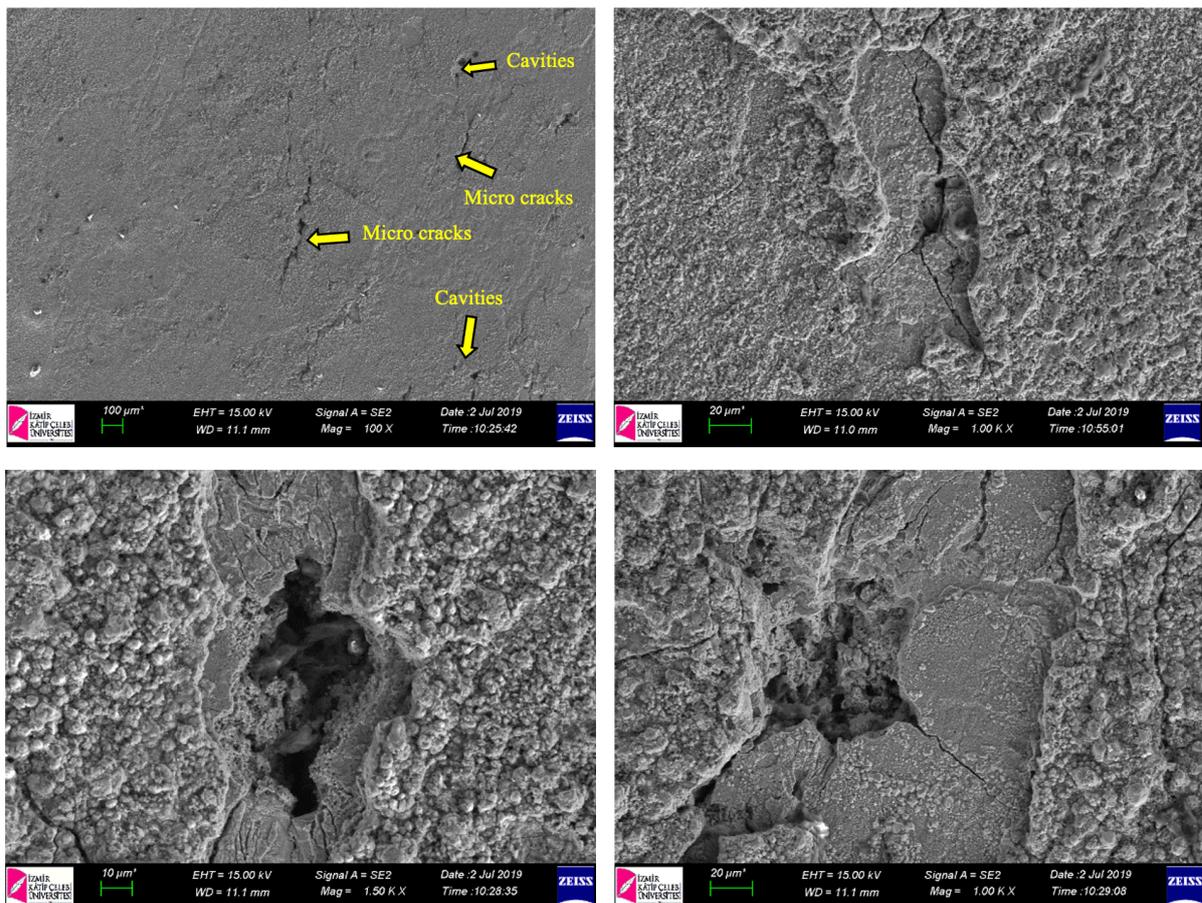
to SEM results, it was determined that the corrosion products on the surface increased over time and at the same time, these corrosion products were too high amount in the samples exposed to corrosion. In order to observe leakage locations more clearly, corrosion products on the surface were removed by gentle cleaning and it was demonstrated in Fig. 6. It was seen that there were various cracks and pits on the surface that could cause leakage, indicated by the arrow in Fig. 6.

formed interior of the copper pipe. Similarly, Cozzarini *et al.* (2020) observed corrosion formations in heat exchangers and detected black corrosion product accumulation and ant-nest corrosion which was similar to our study. In our study, when the SEM images of the corroded C3 sample found in Fig. 6 were compared with the literature, pits and cracks

FIGURE 6. SEM images of C3 sample inner surface (leakage areas).

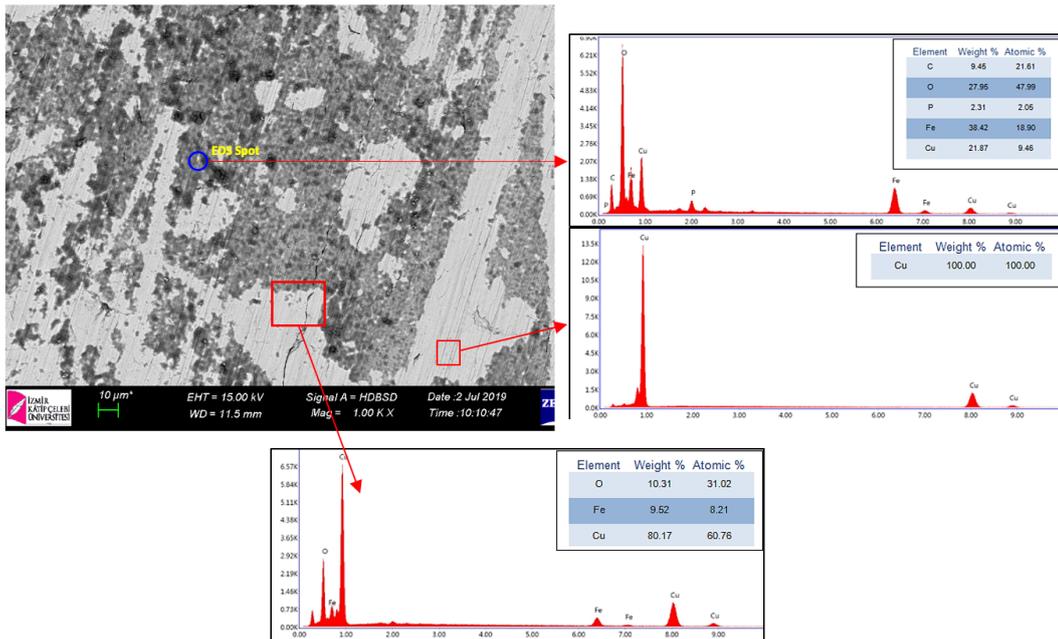
Figure 7 demonstrated elemental analysis of C1 sample inner surfaces by EDS analysis. The observed contamination-like structures were revealed that these regions contain elements such as Cu, O, Fe, P and C. It was determined that the light-colored areas were metallic copper and contained only Cu, while the gray and black areas contained Cu, O and Fe elements. Figure 8 showed elemental analysis of C2 sample inner surface. As a result of the EDS analysis, Cu, O and Fe elements were determined on the sample surface along with small amounts of Si, Ca and S. While the light-colored regions contained only Cu, O and Fe, elements such as Si, Ca and S were also seen in the regions where dark deposition was higher. It was seen that Fe element concentration increased in the dark areas where the contamination and amount of deposition increases. The heat exchangers from which the copper tube samples were taken are connected to installations consisting of steel tubes. Thus, steel pipes which were connected to the heat exchangers, were determined as one of the main reasons for the existence of Fe element on the inner surface of samples. Furthermore, another reason for the existence of elements such as Fe, Si, Ca and S was thought to be mains water, since it circulates through these installation pipes and copper pipes.

FIGURE 7. Elemental analysis of the C1 sample.

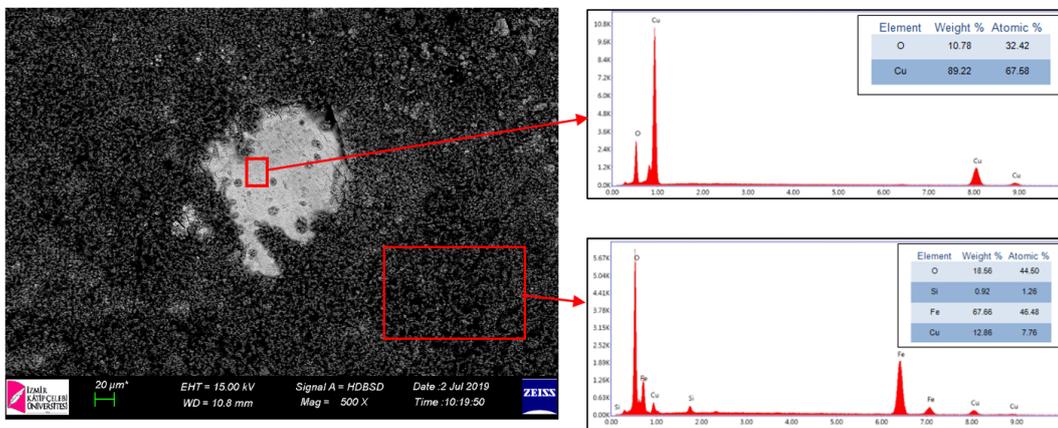
The elemental analysis of the inner surface of failed sample C3 was given Fig. 9. It was seen that the light-colored region contains Cu and O, and the dark colored corrosion product covered region contains Cu and O as well as Fe and Si elements. It was determined that the corrosion product formed on the surface contains high amounts of Fe and O elements. Kuźnicka (2009) examined the corroded copper heat exchanger that has been used for 5 years and detected pits and surface microcracks formations. Their EDS analysis showed that the corrosion products formed on the inner surface consisted of elements such as Fe, Si, C, and Ca. Similarly, Lachowicz (2020), performed EDS analysis on the corrosion products on the inner surface of a damaged copper pipe and their results showed that while the light-colored copper pipe region consisted of Cu

FIGURE 9. Elemental analysis of the C3 sample.

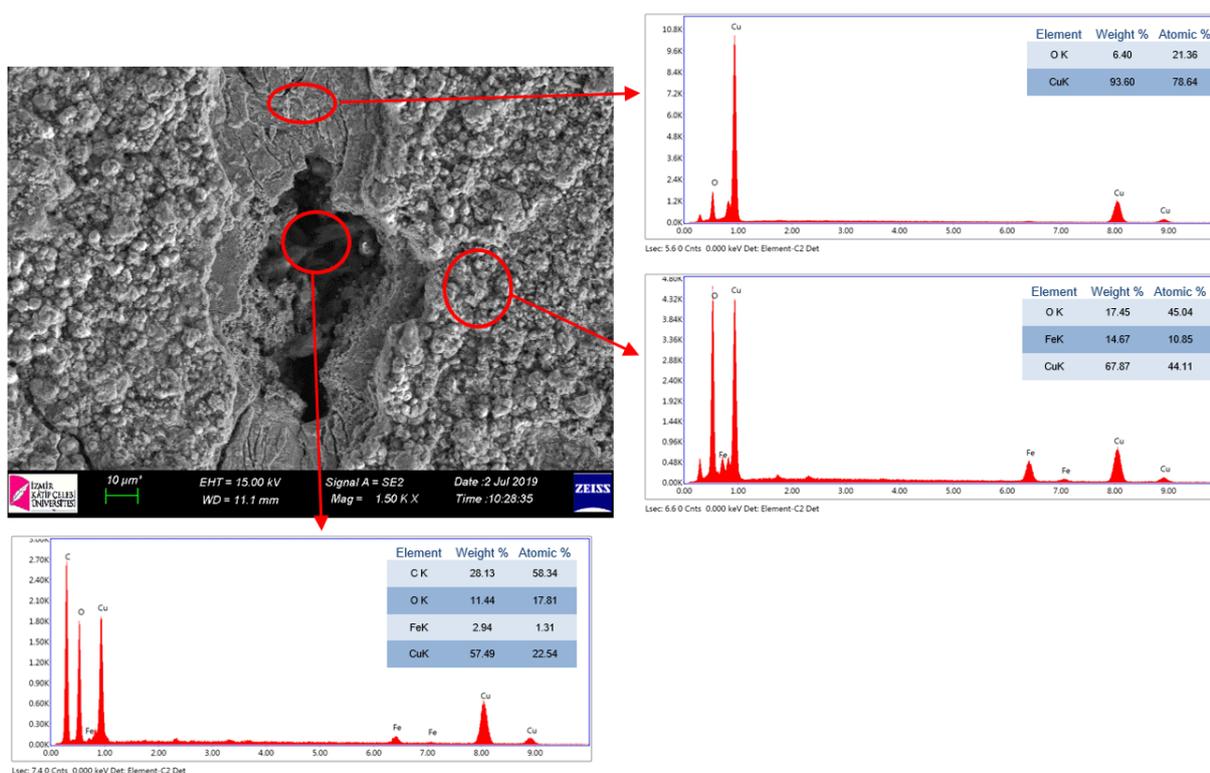
For better understanding of corrosion formation, elemental analysis of the gently cleaned leakage area of the C3 sample were given in Fig. 10. While the analysis made from the pit's edge and corrosion product area showed the occurrence of Cu and O along with Fe, analysis carried out inside the pit revealed the existence of a high percentage of C element. When the studies in the literature were examined, it was seen that the amount of C was higher in the EDS analysis performed from the leakage area compared to the other regions. It was stated that the reason for this is the formic acid-like structures that play an active role in the formation of ant-nest corrosion (Zhou *et al.*, 2018). Bastidas *et al.* (2006) pointed that the formic acid which is essential in ant-nest corrosion can be generated by the pyrolysis of ethylene glycol or hydrolysis of various organic solvents that contains chlorine. Therefore, it was concluded that the EDS results obtained in our study were compatible with the literature and that C element in the leakage area was caused by acidic formations.

FIGURE 10. Elemental analysis of C3 sample inner surface (leakage area).

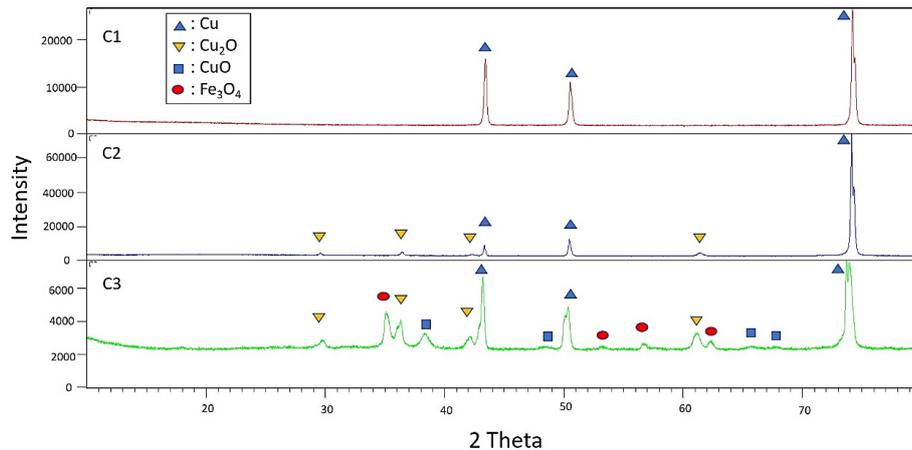
Although O and Fe elements were detected on the surface of C1 sample by EDS, in the XRD analysis of the C1 sample only metallic Cu peaks were seen. Since there were no other phases beside copper, it was understood that corrosion and oxidation occurrences did not occur in sample C1. XRD analysis results of C2 copper pipe, which was used for 2 years, showed that there were two different phases in the structure. One of them was metallic Cu and the other one was Cu₂O (copper (I) oxide). It was understood that contamination product was formed in the copper pipe during the 2-year usage period. Since

FIGURE 11. XRD patterns of C1, C2 and C3 samples.

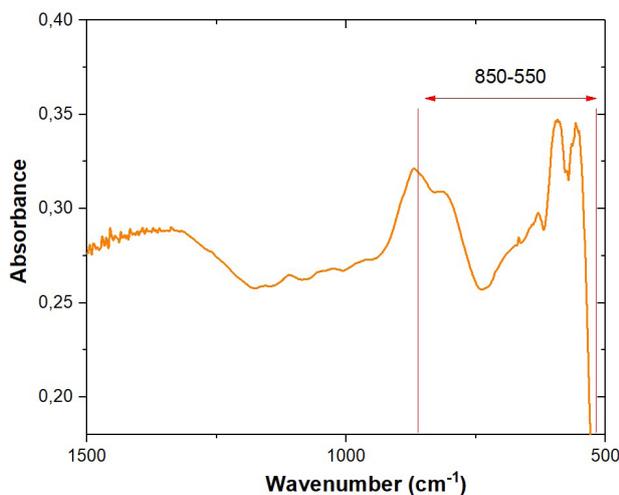
FIGURE 12. FTIR spectra of corrosion products of C3 sample

ple. Bands around between the 850 cm^{-1} and 550 cm^{-1} (Khan *et al.*, 2016) corresponds to C-Cl stretching caused by presence of Cl in mains water circulating in copper pipe. Thus, the presence of Cl ions in the water in the system is proven.

All in all, we can conclude that main reason of corrosion was depended on the amount of ethylene glycol type additives, chloride ion concentration and pH value of water which resulted with the formation of formic acid in coolant water.

Considering all the results, it was concluded that C3 sample failed because of ant-nest corrosion. The presence of Cl in the working environment was detected by FTIR analysis. As a conclusion, it was concluded that the factors that cause the formation of ant-nest corrosion are ethylene glycol type additives, organic solvents containing chlorine and the pH value of the water. For this reason, it is thought that checking the pH value and contents of water periodically may provide a benefit to prevent corrosion.
