Hot tearing in extruded brass for machining applications^(*)

R. Mannheim* and J. Garin*

Abstract

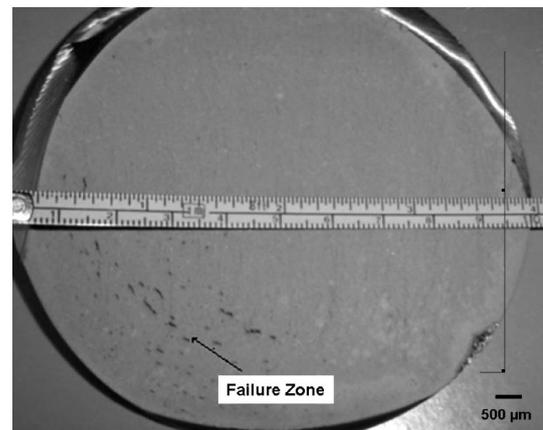
The chemical composition of the 101 mm rod was obtained with an optical emission spectrometer, see table 1. The rod that fractured after extrusion can be observed in figure 1.

Figure 1. Fracture of the 101 mm diameter rod. The arrow indicates the area of cracking.

— The fractured 101 mm extruded rod was observed to have a strong concentration of tearing in the upper part of the rod, which is the area of higher temperature.

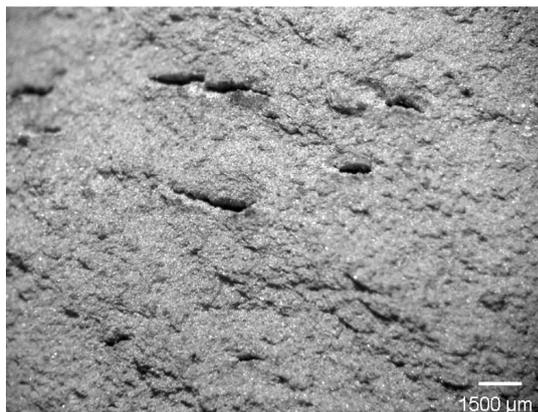
On the other hand, the appearance of the surface tearing is shown in figure 2 in comparison with figure 3, where normal surface is disclosed.

Figure 2. Fractography of the sample failure.

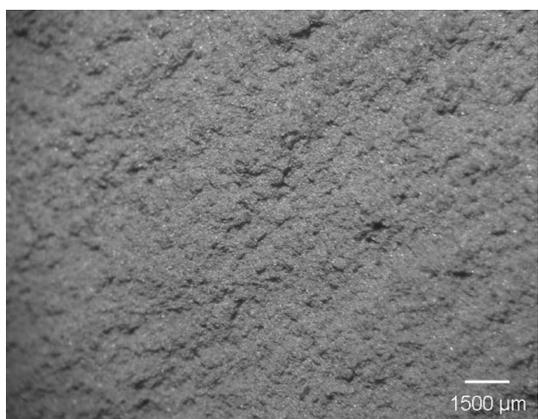
Figure 3. Fractography of the without hot tearing simple.

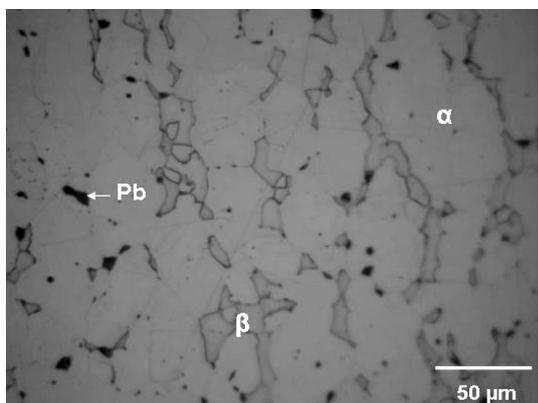
The micrograph in figure 4 shows the presence of three phases; alpha, beta and lead, in a view perpendicular to the direction of the extrusion. Anomalies in the microstructure do not appear in this image. In contrast, in figure 5 an area in the direction of the extrusion can be observed in which

Figure 4. Micrograph of the rod perpendicular to the direction of the crack, 500x.

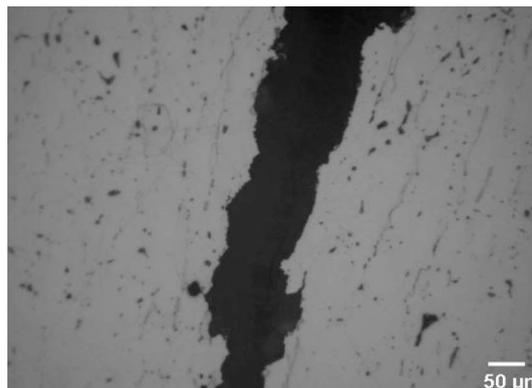
Figure 5. Micrograph of the rod parallel to the direction of the extrusion beginning of the crack, as polish.

In contrast, in figure 5 an area in the direction of the extrusion can be observed in which it is possible to note the beginning of small tears that can subsequently be seen more clearly in the SEM micrograph.

In the failure analyzed in the present work, hot tearing is caused by chemical segregation (Figs. 9, 11, 13 and 14) as a product of the high temperature in the extrusion process. Because of this, the die-rod contact time in this alloy should be sufficiently brief to avoid heating over the limit of 500 to 600 °C. In fact, the larger the ram speed, the smaller the heat transmitted to the die. For the rod under study, the extrusion temperature was 720 to 730 °C. Considering that tension is the main factor causing hot tearing, this can be generated by the longitudinal tensions during the extrusion processes (Fig. 5).

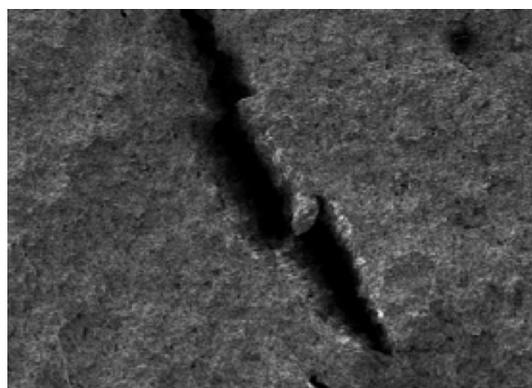
Figure 6 shows “shear intergranular cracks” that run in the direction of the extrusion and on the

Figure 6. Area of tearing observed with SEM at 35x.

fractured surface. Nevertheless, the crack is parallel to the direction of the extrusion and can be observed in 35 x image.

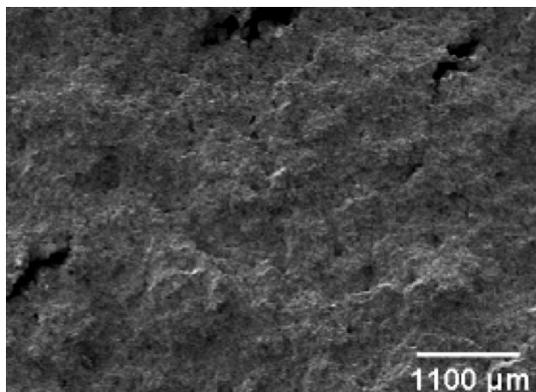
Figure 7 shows numerous cracks running parallel to the direction of extrusion that naturally result in piece with low or no air/water-tightness. Figures 6 and 7 were made with scanning electron microscope, SEM.

Figure 7. Area of secondary cracks with SEM at 35x.

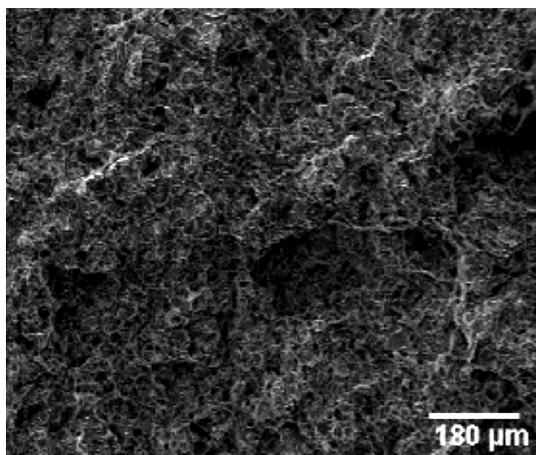
In figure 8 the surface topography with a magnification of 200x can be observed. In general, observation

Figure 8. Fractography using SEM with secondary electrons at 200x.

suggests that there is a fragile intergranular fracture, with the presence of numerous secondary microcracks (Fig. 7). In figure 9 the distribution of lead on the fractured surface can be observed, with a resolution of 200x, this micrograph was done by BEI. It can be noted in figure 9 that the areas of lead are condensed in certain points, the aforementioned effect is made evident observing figures 10 and 11 at 1000x. Figure 12 shows with greater clarity the tearing of the fragile fracture in one of innumerable secondary cracks of

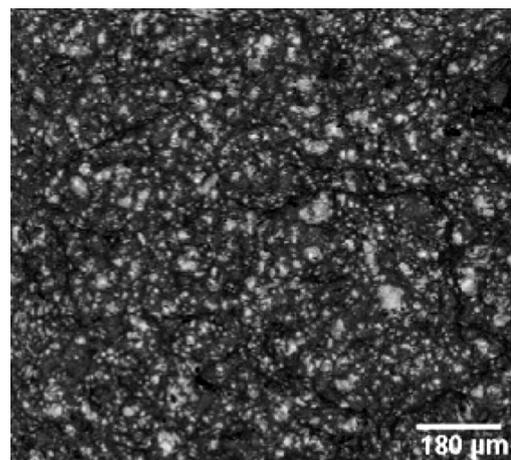
Figure 9. Fractography using SEM with backscattering at 200x, bright points indicate presence of lead.

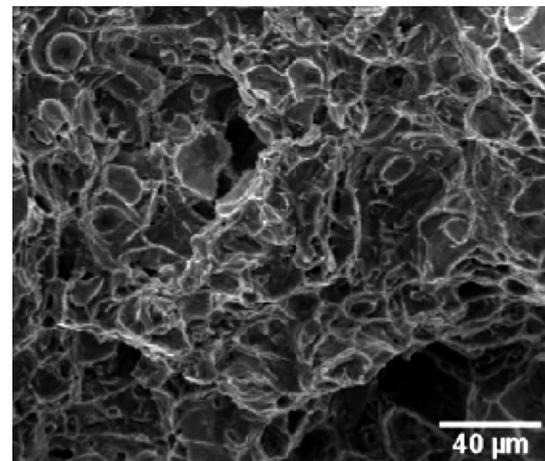
Figure 10. Fractography using SEM with secondary electrons at 1000x.

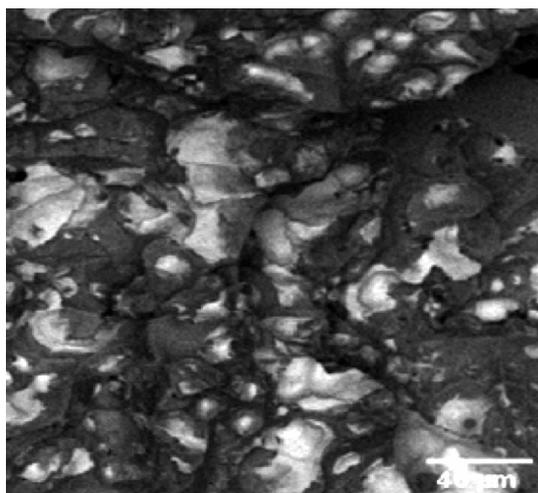
Figure 11. Fractography using SEM with backscattering at 1000x, bright points indicate presence of lead.

- The process of deformation associated with each stage of solidification reaches a particular state in which a bath film separates in dendrites from the others (see figures 11 and 13). In this case, the morphology of solidification plays a fundamental role and the fissuring is favored by rough exogenous columnar microstructures (see figures 4 and 5).
- Once the first crack is formed, it can grow through a grooving effect with the concentration of force as a product of heterogeneous cooling.
- A filled crack can appear again (secondary cracks), because the remaining liquid can segregate and reduce the resistance of the film^[5].

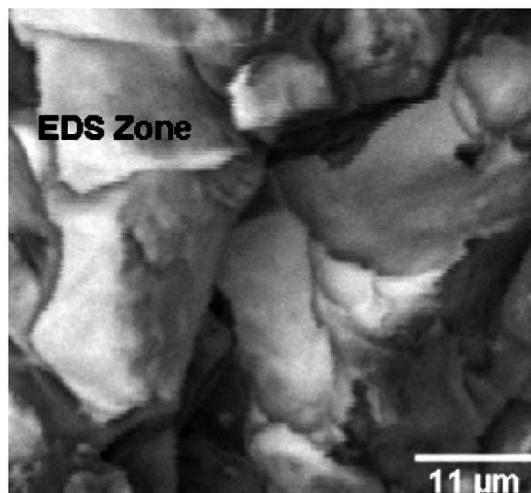
Figure 13. Fractography using SEM with backscattering at 3500x, bright points show the lead condensation.

the 101 mm rod. The extreme concentration of the lead can be appreciated in figure 13 with BEI, which is confirmed in an x-ray analysis (EDS), figure 14.

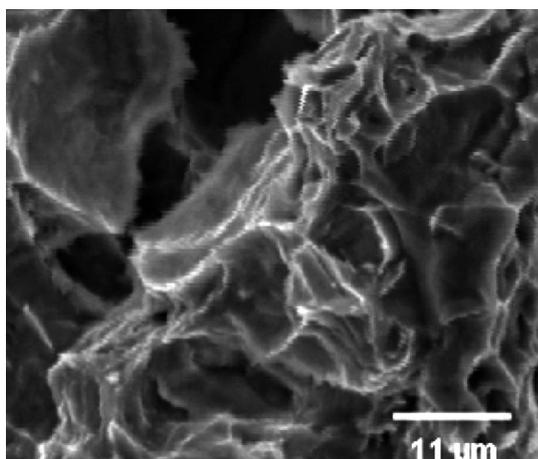
Figure 12. Fractography using SEM with secondary electrons at 3500x.

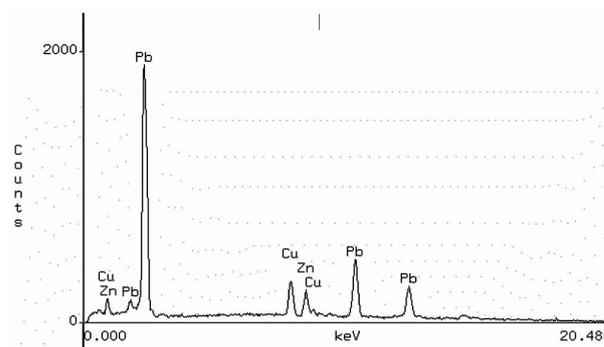
Figure 14. Dispersive energy spectrum of the white areas in the figure 13.

very high temperature of the billet 720-730 °C, a low extrusion ratio 4.1/1 and a very low extrusion ram speed 17 mm/s. To avoid this effect the temperature of the billet could be lowered to 680-690 °C and the extrusion ram speed increased to 40 mm/s.

—
Upon lowering the initial temperature of the billet with this increase in extrusion ram speed, hot shortness can be avoided by shortening the contact time between the die and the extruded rod.
