## Deterioration of ancient metallic elements taken from Toledo cathedral<sup>(\*)</sup>

Juan Guillermo Castaño González\*, Concepción López de Azcona\*\*  
and Manuel Morcillo Linares\*\*\*

**Keywords** Atmospheric corrosion. Toledo cathedral. Lead. Iron. Architectural heritage.

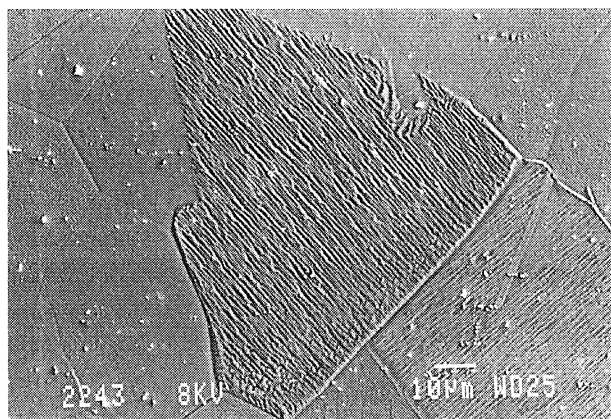
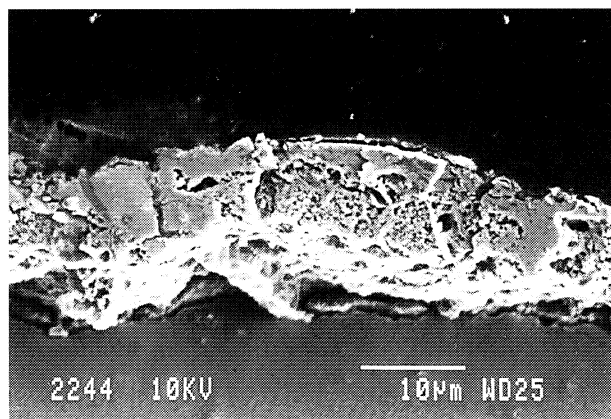
The surface is highly homogeneous, it being possible to observe grains of large size and irregular shape. Some grains present a parallel "fibrous" texture associated with slip lines (fig. 1a). Slip lines can appear because low melting point and low creep strength of lead. The general spectrum of the specimen indicates that it is lead of high purity (close to 100%).

A very thin and uniform corrosion products layer is observed at the edges, with a thickness of approx. 15 µm (fig. 1b). EDX analysis of this layer reveals the following composition: lead (44.73%),

**Figure 1.** SEM images of the roofing lead, (a) Photograph in which grains of a fibrous appearance can be observed, (b) Corrosion products film, whose thickness is approximately 15 µm.

carbon (35.17%), oxygen (16.37%) and traces of phosphorus and calcium. Probably, lead carbonates are the principal corrosion product formed in this layer. Carbonates are typical compounds found in atmospheric corrosion of lead.

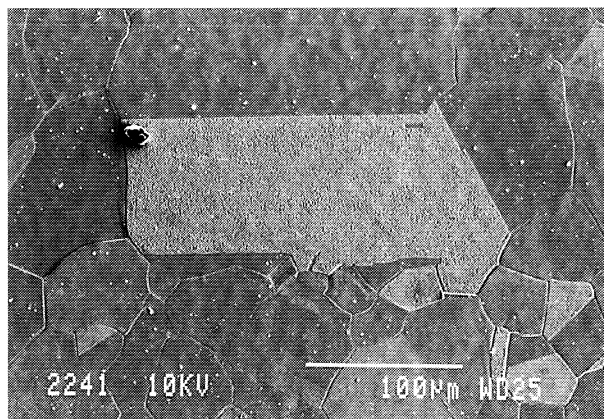
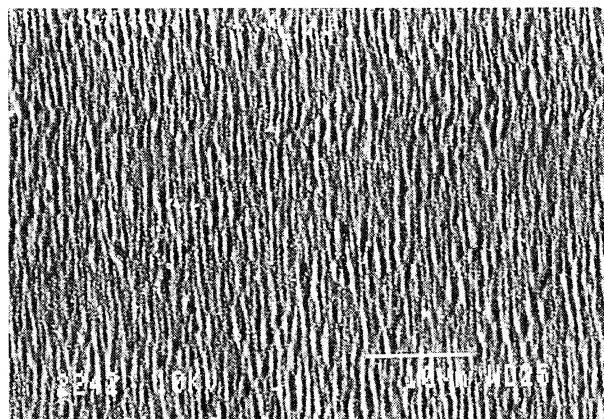
**Figure 2.** SEM images of the lead clamp, (a) Photograph in which the grains can be observed, (b) Detail of the central grain with a fibrous appearance.

darker than others due to greater oxidation of the surface (fig. 2a). At 2000 magnifications the slip lines texture described in the previous case can clearly be seen (fig. 2b). In this case, slip lines appear in major extent, probably due to fatigue phenomenon.

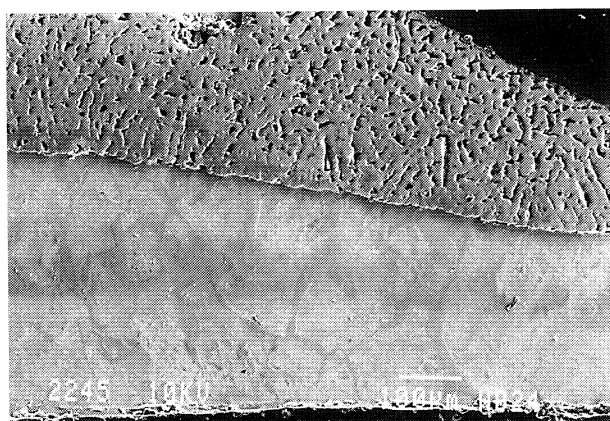
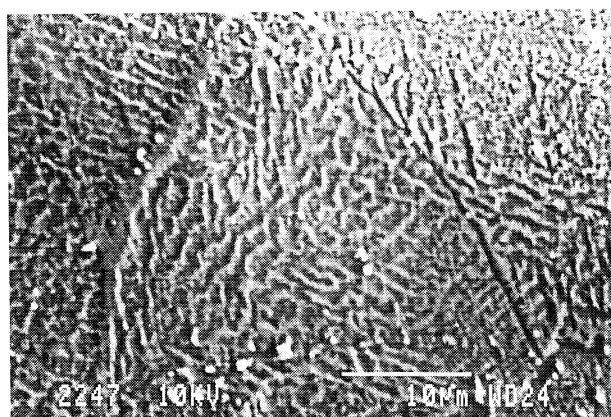
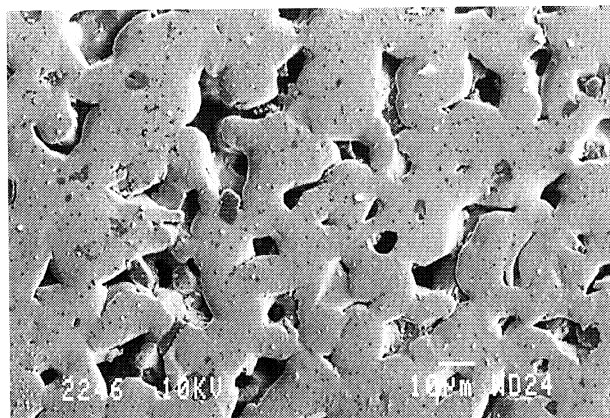
**Figure 3.** SEM images of the window lead, (a) There is a clear differentiation between lead-rich regions (light grey) and tin-rich regions (darker), (b) Detail of the lead-rich region, showing its very fine arborescent morphology, (c) Detail of the tin-rich region, with a porous morphology similar to a cheese.

first is light and uniform (more extensive), while the second is darker and appears in fewer places (fig. 3a).

The more uniform zones are comprised almost totally by lead, and when observed at sufficient magnification (2500 X) a dendritic or arborescent texture is appreciated. The grain size is very small (fig. 3b). In the darker zones the main component is tin. The surface has the appearance of being full of holes, like a cheese (fig. 3c).

A lead alloy with approx. 3% Sn, at steady state, must show a monophasic microstructure with equiaxial grains. The appearance of darker zones is possible due to segregation process during solidification. This segregation allows the formation of Sn-Pb lamellar eutectic phase, which remains in the material during conformation process. For other hand, it is possible that porosity appears during solidification process.

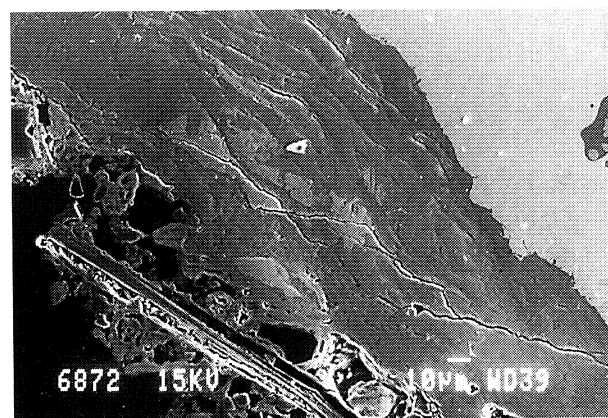
Figure 4 clearly shows an outer layer of corrosion products and a more or less homogenous inner layer.

The spectrum of the outer layer shows that its main component is iron, also detecting oxygen and sulphur. This is a very compact and relatively

**Figure 4.** Corrosion products layer of the iron nail, with a thickness of between 120 and 160 μm.

thick layer, with a thickness of between 120 and 160  $\mu\text{m}$ . Deterioration of nail is slight. According to this information, although nail is placed in an aggressive environment, the corrosion products (mainly Fe hydroxides) exhibit protective characteristics.

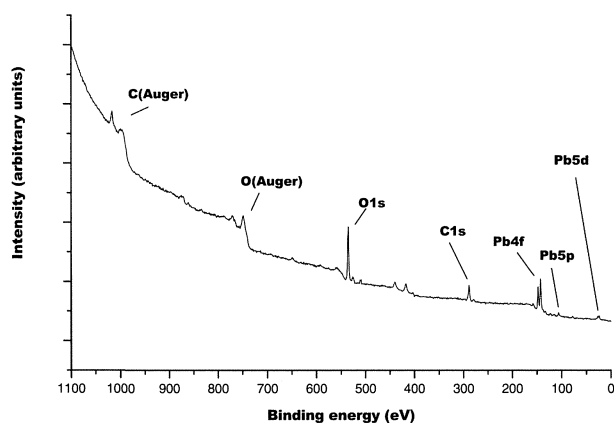
Figure 5 shows the general spectrum for the lead specimens, which is representative for all three specimens analysed. There is little difference between the original specimen and after one minute of argon sputtering.

According to the information given by the different peaks in the general spectrum, the outermost surface of the specimens is formed mainly by lead oxides and carbonates.

**Figure 5.** General XPS spectrum characteristic of the lead specimens, indicating the main elements found (carbon, oxygen and lead). The spectrum of the roofing lead only differs in that sulphur is detected (S2p).

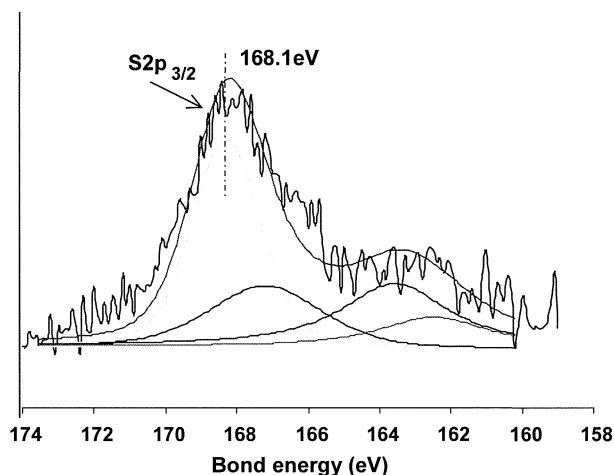
Lead sulphates have also been found on the roofing lead. Figure 6 shows a high resolution spectrum of the S2p peak, which indicates the presence of this compound.

**Figure 6.** High resolution spectrum of S2p obtained in the XPS analysis of the roofing lead.

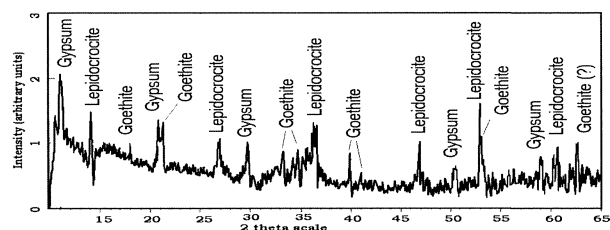
XRD analysis was carried out on the nail's corrosion products layer (Fig. 7), indicating that this is comprised mainly by Goethite ( $\gamma\text{-FeOOH}$ ) and, to a lesser extent, Lepidocrocite ( $\gamma\text{-FeOOH}$ ). Some gypsum ( $\text{CaSO}_4 \cdot 2\text{H}_2\text{O}$ ) is being detected, but this

compound is originating from the rendering that the nail supported

**Figure 7.** XRD spectrum of the nail corrosion products layer, in which lepidocrocite, goethite and gypsum have been detected.

Some gypsum has also been found adhered to the rust, whose origin lies in the rendering that the nail supported. The presence of sulphur detected in the EDX analysis may be due to this compound. Gypsum contributes to accelerating the corrosion of iron and steel, and thus it is not recommendable to combine these materials.
