## Copper alloys deterioration due to anthropogenic action<sup>(\*)</sup>

A. Duran\*, J.L. Pérez-Rodríguez\*, L.K. Herrera\*, M.C. Jiménez-de-Haro\*, M.D. Robador\*, A. Justo\*, J.M. Blanes\* and J.C. Pérez-Ferrer\*

### 1.1. The Pardon Gateway of the Mosque-Cathedral of Cordoba

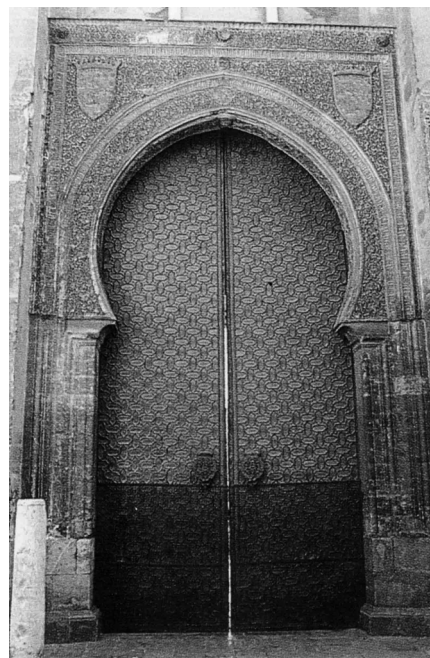
Figure 1. Pardon gateway of Mosque-Cathedral of Cordoba.

The gateway was rebuilt in 1739. The leaves were in a good conservation state until the middle of the XX century, when a sudden alteration began after being subjected to a cleaning process. The alloys and the rivet used to fix the plaques presented a high degree of oxidation. This deterioration was attributed to a wrong cleaning procedure with an inappropriate product, and it was necessary to stop the deterioration process as well as to eliminate the corrosion products.

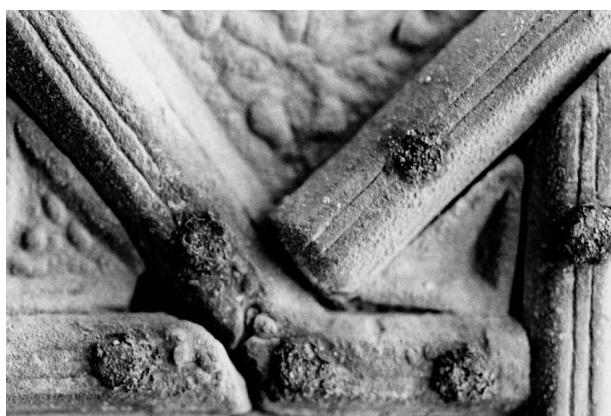
**Figure 2.** Details of the rivets.

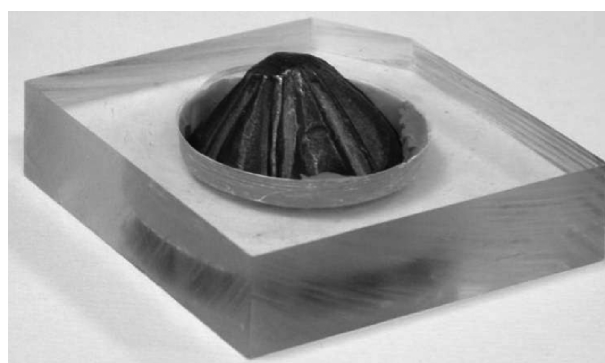
**Figure 3.** Separated fragment (nail) from the top of the door.

The chemical analysis carried out directly in the fragment of the sample 6 after cleaning still shows the presence of Cl, together with Cu, Sn, Pb, Fe and small amounts of Zn, showing the difficulty to remove ion chlorine.

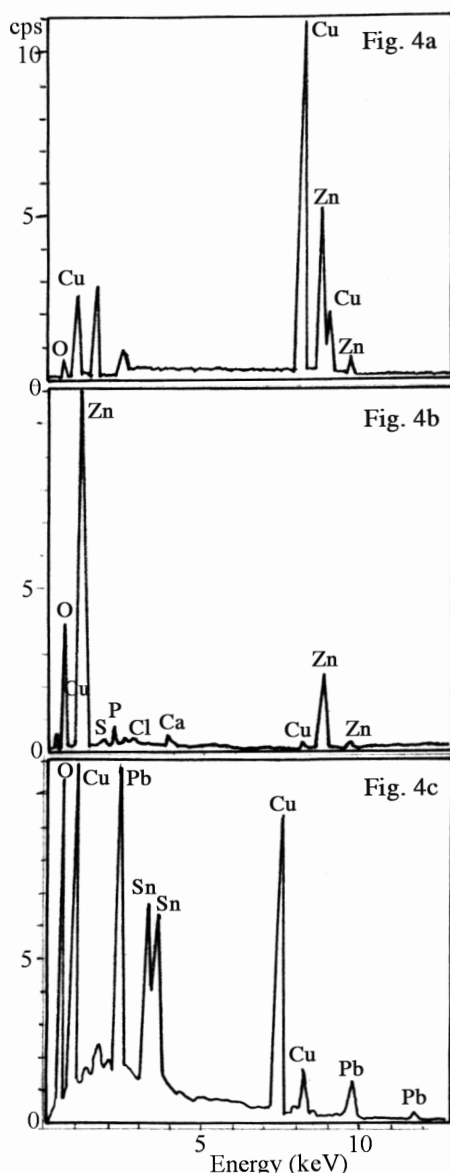
In a first step, the alloys used in the leaves construction were characterized. The elemental analysis of sample 1 shows that the original material is constituted by copper and zinc (Fig. 4 a)). Punctual chemical analysis in this sample shows the presence of Zn (Fig.4 b)). The x-ray diffraction patterns of this sample support the presence of copper zinc alpha brass (figure not shown). The chemical composition and phases found for sample 3 are similar to those present in sample 1. These results confirm that these materials are constituted by copper zinc alpha brass. This alloy is present in a small part of the leaves, mainly in the edges.

The elemental analysis of sample 2 shows the presence of Cu, Sn and Pb (Fig.4 c)). A similar composition was found for sample 6 accompanied by Fe and small amounts of Zn. The X-ray diffraction patterns of this sample show that it is constituted

**Figure 4.** Elemental analysis of sample 1. (a) general and b) punctual; and sample 2 (c) general).

Also, punctual elemental analysis in samples 1 and 3 shows the presence of Zn and O (Fig.4 b)). This finding may be attributed to formation of ZnO (zincite). When zinc is exposed out-doors initially form zinc oxides<sup>[14]</sup> that may be transformed into a basic zinc compound. It is possible that ZnO identified in this sample resulted from the corrosion of freshly exposed zinc. This phase has not been detected by X-ray diffraction.

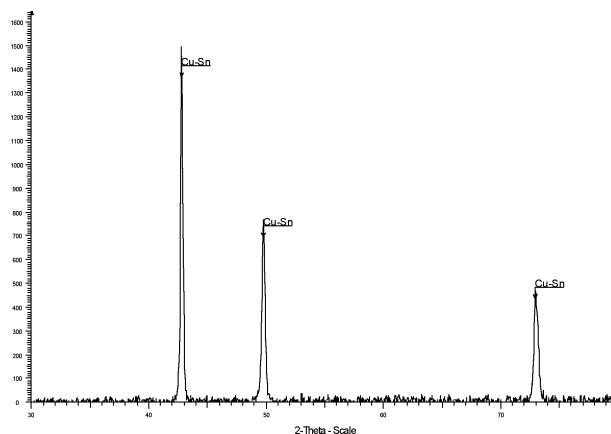
by copper-tin alpha brass (Fig. 5). The x-ray diffraction patterns of this last sample has been carried out on the sample after cleaning by restaurators using a Göbel accessory that allow the direct study of irregularly shaped samples avoiding to obtain any powdered sample from the pieces, that it was not permitted by restaurators due to high artistic value of this piece. In figure 3 it is shown the montage used to obtain the x-ray diagram of these samples.

**Figure 5.** XRD patterns of unaltered material of sample 6 (Cu-Sn).

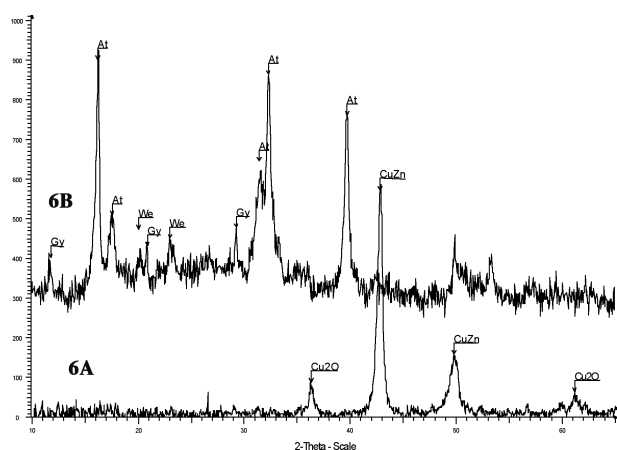
Elemental analysis of the samples 1 and 3 shows the presence of copper and oxygen. This last element is difficult to attribute to the oxidation of Cu because may form part different compounds present in the base material. However, the x-ray diffraction powder taken directly from the sample shows the presence of  $\text{Cu}_2\text{O}$  (Fig. 6 a)).

**Figure 6.** XRD patterns of oxidized material of samples 1 and 3 ( $\text{Cu}_2\text{O}$  and  $\text{Cu-Zn}$ ) (A) and XRD patterns of corrosion and environmental contamination products of samples 1 and 3 ( $\text{Gy}$ =gypsum;  $\text{At}$ =atacamite;  $\text{We}$ =weddellite) (B).

The elemental analysis of corrosion products from samples 1 and 3 show the presence of copper, chlorine, zinc, silicon, sulphur, calcium, iron, aluminium and oxygen (Fig. 7 a)) The XRD patterns shows that the sample is constituted by atacamite (basic copper chloride), gypsum and weddellite (Fig. 6 b)). Atacamite has been detected previously in copper and copper alloys exposed outdoors due to environmental contamination. This environmental contamination is also responsible of the presence of gypsum and quartz. Both may also come from the restoration process that was carried out around the gateway. The weddellite, also present, may be formed by reaction between environmental gypsum or calcite, with oxalate ions from dissolved acid. In urban areas oxalic acid is abundant in rain and mists<sup>[16]</sup> or it may be secreted by micro organisms, such as fungi and liquens<sup>[17]</sup>.

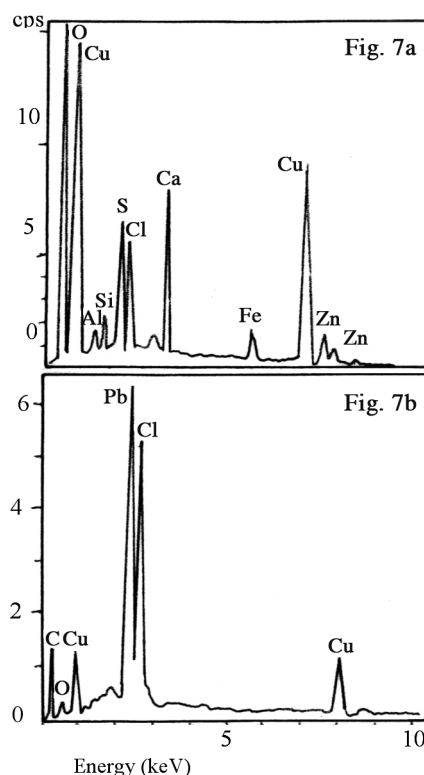
**Figure 7.** Elemental analysis of corrosion products a) from samples 1 and 3 (general); b) and sample 4 (punctual).

The sample 4 was taken from corrosion products that practically cover the two leaves of this gateway. The main component is the atacamite according with the results obtained by chemical analysis and XRD (figure not shown). Punctual analysis shows that some particles are constituted only by lead and chlorine (Fig.7 b)) confirming that the lead has been also attacked by chloride ions. This phase has not been confirmed by x-ray diffraction due to the scarce amount of the sample.

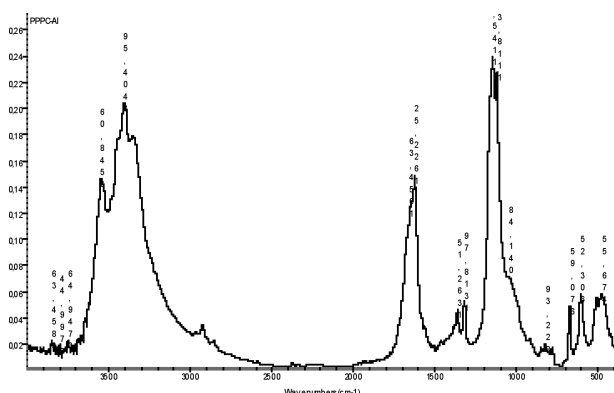
The infrared spectra of different corrosion materials from these leaves show characteristic bands of atacamite, gypsum and quartz. It also appears a band at  $1622\text{ cm}^{-1}$  assigned to oxalate (Fig. 8).

**Figure 8.** IR spectrum of corrosion (oxalate –band at  $1622\text{ cm}^{-1}$ –; atacamite –bands at  $3548\text{ cm}^{-1}$ ,  $3404\text{ cm}^{-1}$ ,  $822\text{ cm}^{-1}$ ) and environmental contamination products (gypsum –bands at  $1145\text{ cm}^{-1}$ ,  $1118\text{ cm}^{-1}$ ,  $670\text{ cm}^{-1}$ ,  $603\text{ cm}^{-1}$ –, quartz –band at  $1041\text{ cm}^{-1}$ –).
