Influence of microstructure on the microbial corrosion behaviour of stainless steels^(*)

Diego Alejandro Moreno*, José Ramón Ibars* and Carlos Ranninger*

Abstract

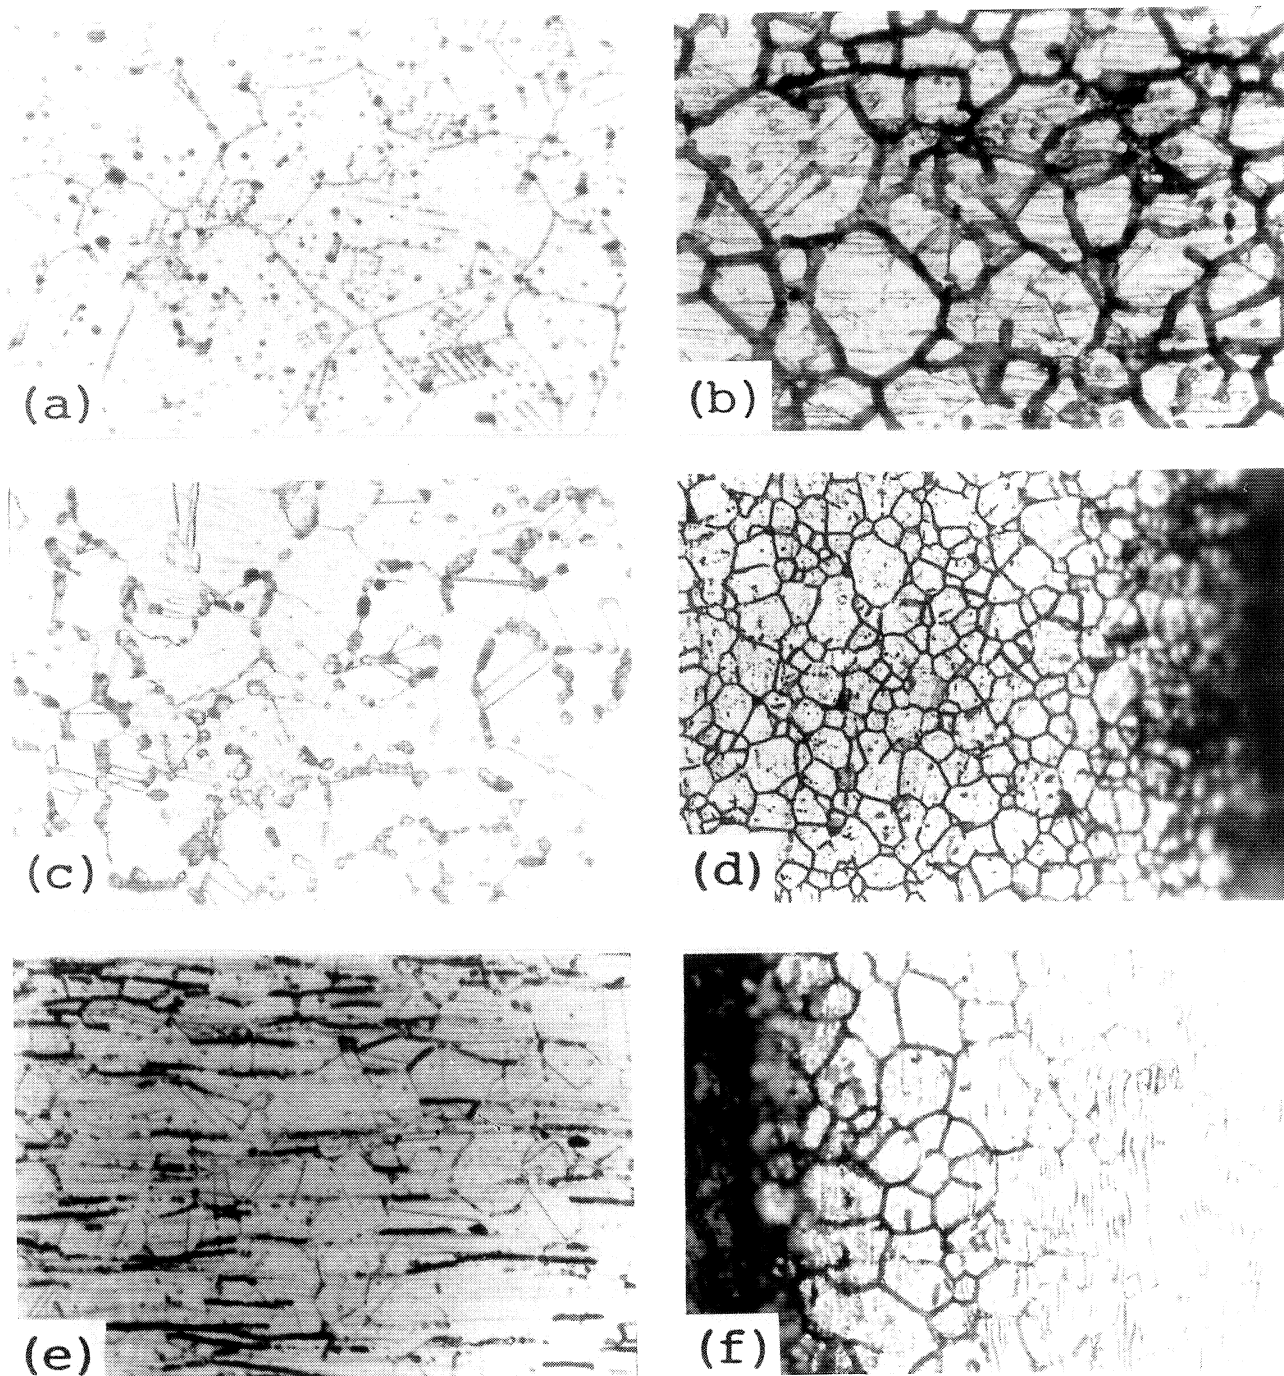
Figure 1. Stainless steels microstructures: a) Type UNS S30300 sensitized 675 °C/4 h (400x). b) Type UNS S30400 sensitized 675 °C/1 h (400x). c) Type UNS S30403 sensitized 675 °C/48 h (400x). d) Type UNS S31600 sensitized 675 °C/48 h, specimen edge (200x). e) Type UNS S31600 sensitized 675 °C/48 h, specimen centre (400x). f) Type UNS S31603 sensitized 675 °C/48 h, specimen edge (200x)

In the austenitic stainless steel Type UNS S30300 in the sensitized state, the carbide precipitation took place at the grain boundary and also at the slip bands (Fig. 1a). The grain boundary ditches are discontinuous (string of pits) and shallow, possibly due to the relatively low carbon content of the steel (0.038 %) and to the fact that the existence of a certain degree of cold deformation has distributed the carbide precipitation between the grain boundaries and the slip bands.

The austenitic stainless steel Type UNS S30400 in the sensitized state showed a marked carbide precipitation at the grain boundaries, giving rise to a structure with continuous grain boundary ditches (Fig. 1b). The degree of sensitization was apparently the same on the surface and in the

The austenitic stainless steel Type UNS S30403 was highly resistant to sensitization. With sensitizing heat treatment (48 h at 675 °C), slight sensitization took place with the appearance of isolated ditches at the grain boundaries (Fig. 1c).

Sensitizing heat treatment in austenitic stainless steel Type UNS S31600 induced the appearance of grain boundary ditches in the surface area (edge of the test specimen), denoting a marked chromium carbide precipitation (Fig. 1d), whereas in the interior there were no grain boundary ditches in significant amounts (Fig. 1e).

In the area close to the surface, the austenitic stainless steel Type UNS S31603 showed a certain tendency to sensitization (Fig. 1f).

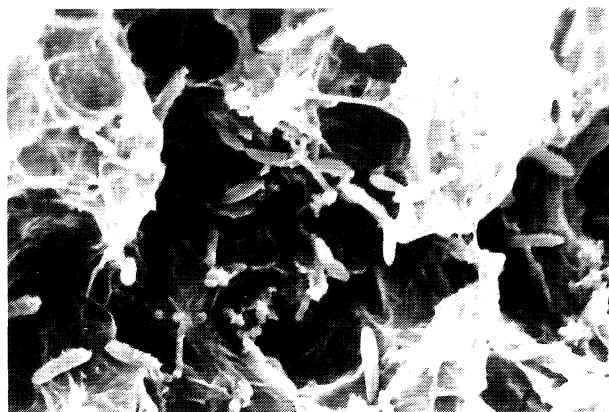
Figure 2. Biofilm of sulphate-reducing bacteria on stainless steel Type UNS S42000 (as-received state) (5,000x) (Printing reproduction at 50 %).

The biofilms formed on stainless steel Type UNS S42000 had a blackish appearance due to the presence of iron sulphide. When analyzed by SEM, metabolic products were found mingled with the microorganisms used (Fig. 2). Qualitative EDX of the biofilms (Fig. 3) revealed an extremely high

In the corrosion zone (Fig. 5) a halo or coloured area around it, similar to those produced in the electrochemical tests carried out in the presence of a medium with metabolites (Fig. 6), can be seen. EDX of the biofilms (Fig. 3) revealed the presence of sulphur, with a much higher peak than in the EDX carried out in an area close to pitting (Fig. 7) and even in the actual pit (Fig. 8). This may be explained by the thickness of the biofilm, in which corrosion products were trapped along with the bacteria (Fig. 2).

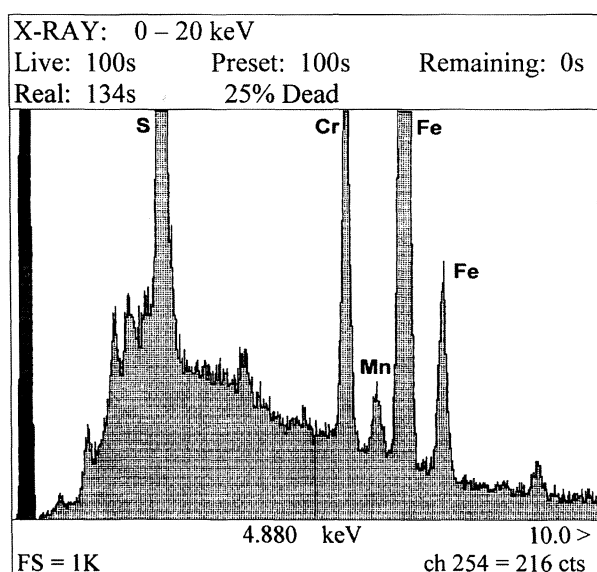
Figure 3. EDX analysis of biofilm on stainless steel Type UNS S42000.

sulphur content. This peak was not found in the base metal (Fig. 4) confirming the formation of an iron sulphide rich film.

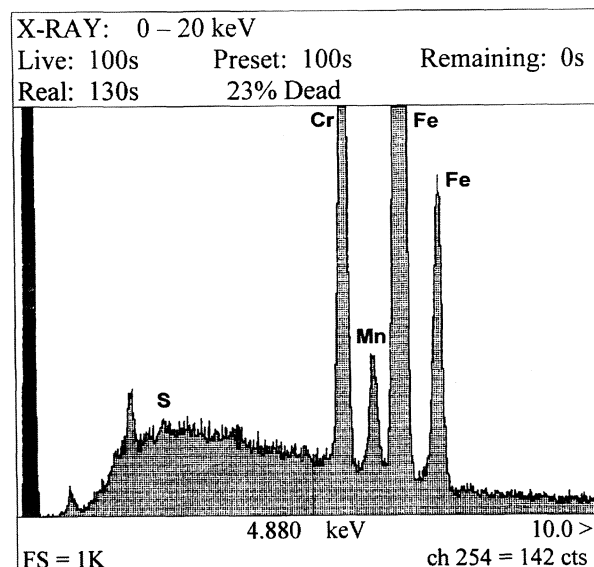
Figure 4. EDX analysis on stainless steel Type UNS S42000 after removing biofilm.

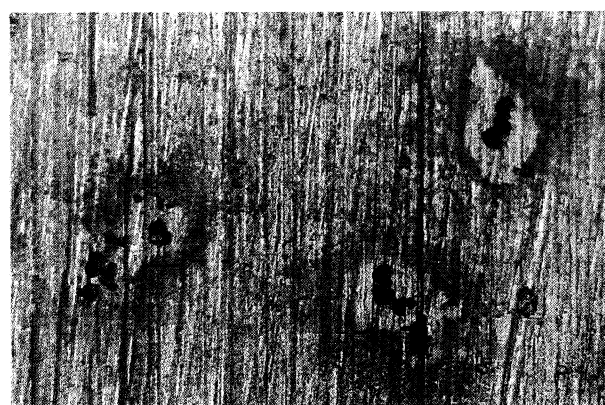
Figure 5. Pitting corrosion attack by sulphate-reducing bacteria on stainless steel Type UNS S42000 annealed (50x) (Printing reproduction at 53 %).

The metallographic study of the coupons under the biofilms showed that stainless steel Type UNS S42000 in as-received state suffered pitting corrosion (Fig. 5). These pits had a non-equiaxed form. This appearance is reminiscent of pitting in case histories of microbial corrosion^[5]. The pits produced in electrochemical tests were equiaxed. In the other stainless steels tested, the development of pitting after 60 days was not confirmed.

In some specific aspects (Figs. 6, 10 and 11) these pits were similar to other corrosion effects of biological origin (Fig. 5) and different from the pits

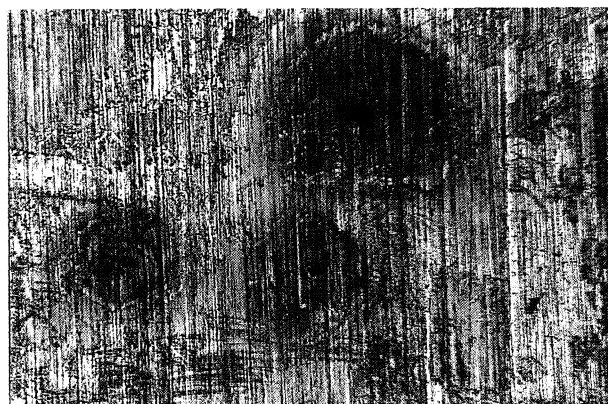
Figure 6. Pitting corrosion on stainless steel Type UNS S30400 sensitized after an electrochemical test using Electrolyte B (50x) (Printing reproduction at 53 %).

Figures 6 and 11 show different materials tested in Electrolyte B. The electrochemical test with this electrolyte was followed visually, even though the pitting current did not reach $10\text{--}15\text{ }\mu\text{A}/\text{cm}^2$, because blackish spots formed on the test specimen, with "threads" of corrosion products, become detached from it as the current density increased. All the pits produced with this electrolyte had a coloured area around them.

In stainless steels Types UNS S30400 and S30300 with sensitizing heat treatment, perfectly defined pits were visible (Figs. 6 and 11), quite different from these obtained when Electrolyte A was used. Some of the pits were very deep ($71\text{ }\mu\text{m}$ for stainless steel Type UNS S30400 with sensitizing heat treatment).

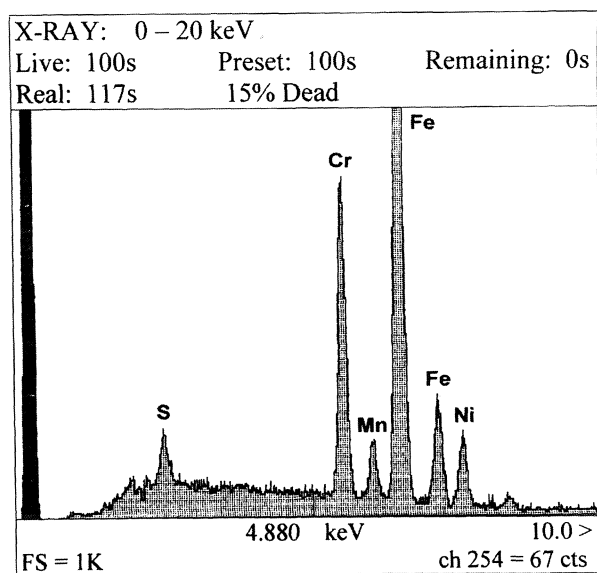
Figure 7. EDX analysis close to pitting on stainless steel Type UNS S31600 sensitized after an electrochemical test using Electrolyte B.

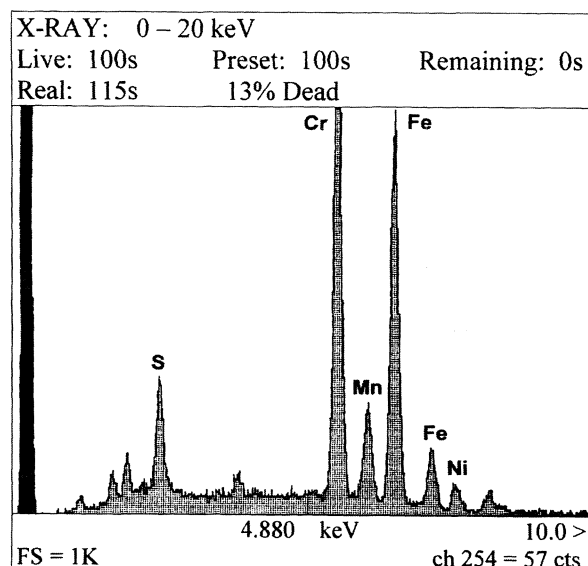
Figure 8. EDX analysis in pitting hole on stainless steel Type UNS S31600 sensitized after an electrochemical test using Electrolyte B.

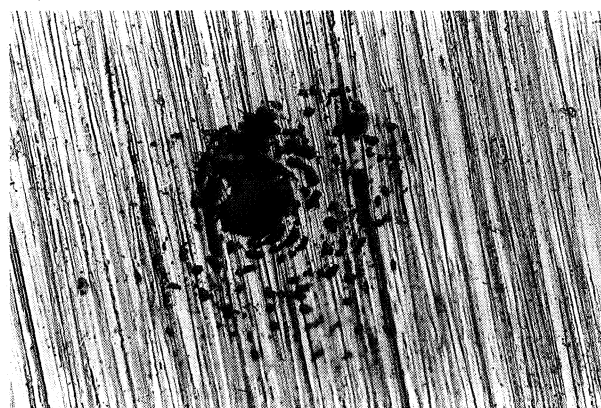
Figure 9. Pitting corrosion on stainless steel Type UNS S30400 as-received after an electrochemical test using Electrolyte A (400x) (Printing reproduction at 53 %).

steel Type UNS S42000. The pits in the austenitic stainless steels Types UNS S30400, S31600 and S31603 in solution annealed state were surrounded by other smaller pits (Fig. 9). This same aspect was reported by Ruijini *et al.*^[36]. These steels exhibited a large number of scattered small pits covering practically the whole area of the test specimen. Stainless steel Type UNS S42000, in as-received state, displayed always not many but larger pits. Its both low chromium content and low PRE (Table I) may perhaps determine this numerical and morphological difference.

For solution annealed austenitic stainless steels, defined pits with concentric figures were observed (Fig. 9). This difference may be due to the fact that for sensitized austenitic stainless steels the pitting potential is lower, so there are many possible places for pit nucleation, such as the grain boundaries with carbide precipitation and chromium depletion, and therefore there is no spot nucleation and subsequent pit development. However, in the solubilized steels, which are nobler, when the pitting potential is reached at higher potentials, there is a greater difference in potential between the pits and the base metal, which gives rise to the appearance of better defined pits.

obtained in a chloride medium for solution-annealed or sensitized austenitic stainless steels (Figs. 9 and 12).

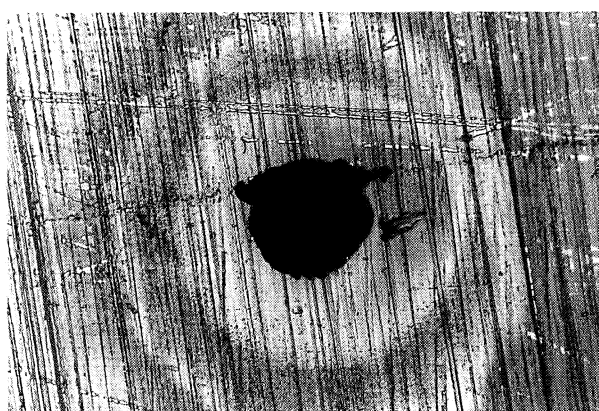
Figure 10. Pitting corrosion on stainless steel Type UNS S42000 quenched and tempered after an electrochemical test using Electrolyte B (400x) (Printing reproduction at 53 %).

For martensitic stainless steel Type UNS S42000 was observed large pits irrespective of the heat treatment state (Fig. 10), although there is a relationship between the E_p values and the heat treatment state.

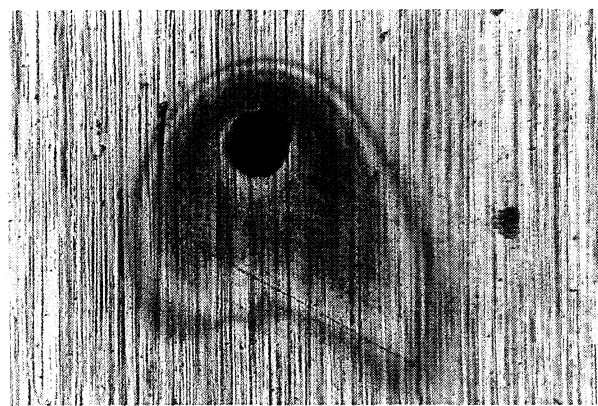
Figure 11. Pitting corrosion on stainless steel Type UNS S30300 sensitized after an electrochemical test using Electrolyte B (100x) (Printing reproduction at 53 %)

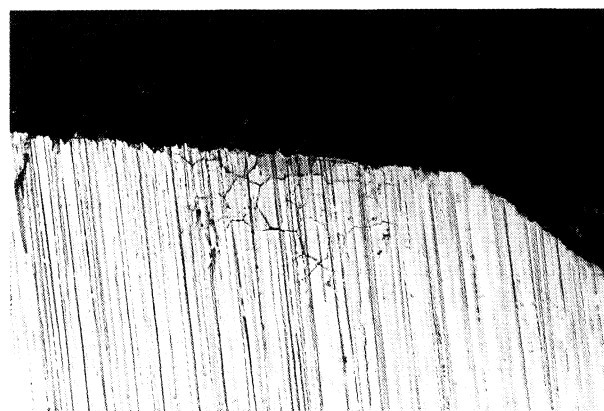
Figure 12. Localized corrosion on stainless steel Type UNS S31600 sensitized after an electrochemical test using Electrolyte A (200x) (Printing reproduction at 53 %).
