Failure analysis of copper pipes used in the heat exchangers in fan coil units

ABSTRACT: Heat exchangers (HE) consist of copper and steel pipes and are used for heating and cooling the ambient air. One of the main problems seen in HE is the leakage on copper pipes. In this study, failed and properly working copper pipe samples used for different durations were examined in detail. The microstructural analyses were performed using optical microscopy (OM) and scanning electron microscopy (SEM) to detect corrosion occurrences on copper pipe surfaces. In addition, corrosion products of the samples were defined by X-Ray Diffraction (XRD), Energy Dispersive Spectroscopy (EDS) and Fourier-Transform Infrared Spectroscopy (FTIR) analyses. The formation of interconnected tunnels in cross section of the failed copper pipe sample that were in microscopic dimensions and corrosion products were observed. Consequently, all the analyses result that were obtained from the samples pointed out a corrosion mechanism known as ant-nest corrosion. It was concluded that the main reason of corrosion was related to ethylene glycol type additives which were used in HE along with mains water.

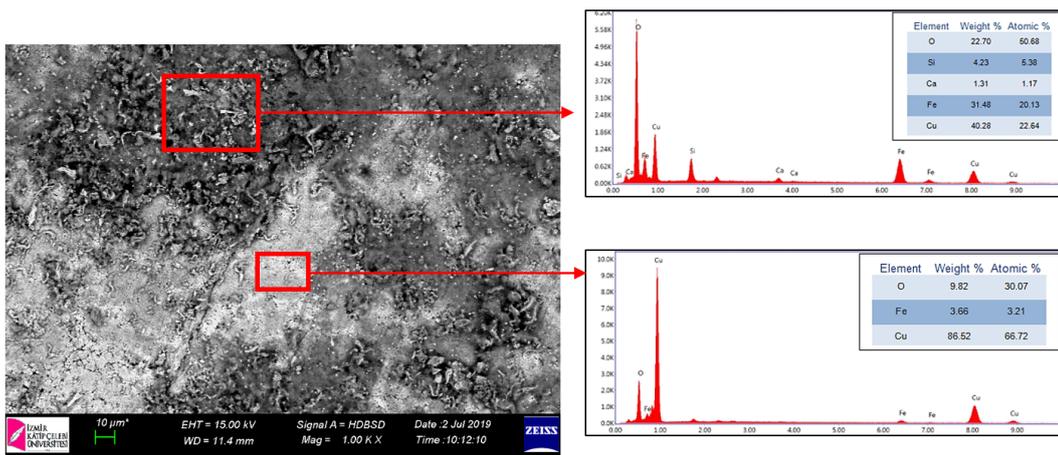
FIGURE 8. Elemental analysis of the C2 sample.

we detected Fe and O elements by EDS on both C1 and C2 samples, we can conclude that these samples were exposed to contaminating environment from two months to two years usage. However, this formation did not cause serious damage to the pipe. Zhou *et al.* (2018) obtained similar metallic Cu phase by XRD for copper pipes that were not exposed to formic acid environment. They also revealed that the exposure of copper pipes to the formic acid resulted with the formation of Cu_2O phase. In accordance, our findings showed that even without corrosion formation, a considerable amount of Cu_2O can deposit on the inner surface of samples. As a result of the XRD analysis of C3 sample, 4 different phases (compounds and elements) such as Cu, Cu_2O , CuO and Fe_3O_4 were detected on the inner surface of the copper pipe. It was found that this sample contained a secondary copper oxide phase along with iron oxide phases that were different from the C2 sample. Cozzarini *et al.* (2020) found Cu, CuO and Cu_2O phases in a copper pipe which was failed due to ant-nest corrosion. They also stated that there was a black corrosion product on the surface of the failed pipes which was similar to our study. In a different study, Bastidas *et al.* (2006) examined the ant-nest corrosion formation under presence of organic acids such as formic, acetic, propionic and butyric acid. The results showed that various copper oxide formations can be found on the surface of corroded samples along with as copper formate
