# Analysis of the degradation process and electrochemical behaviour of AZ31 magnesium alloy in artificial saliva

Emmanuel Mena-Morcillo, Lucien Veleva<sup>⊠</sup>, Luis J. Espadas-Herrera

Center for Investigation and Advanced Study (CINVESTAV-IPN), Applied Physics Department, Carr. Ant. a Progreso km. 6, C.P. 97310, Mérida, Yucatán, México ⊠Corresponding Author: veleva@cinvestav.mx

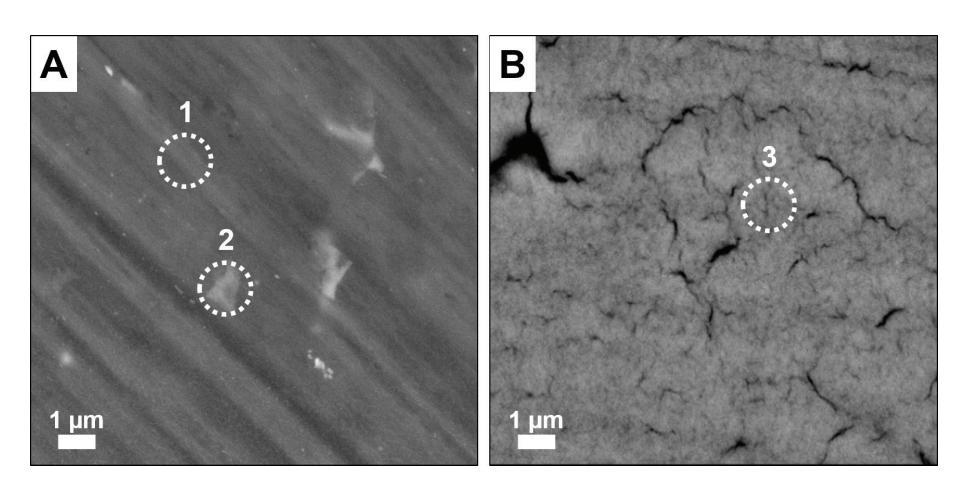
FIGURE 1. SEM images of the surface of AZ31: (A) prior to the HF-treatment, (B) after the HF-treatment. The marked regions indicate the sites were EDS analysis was performed.

Figure 1 shows SEM images of the AZ31 surface before and after the treatment in HF. Table 1 present the EDS quantification of the marked sites in Fig. 1. The bare surface of the alloy displays the typical microstructure of AZ31 (Mena-Morcillo *et al.*, 2018), where the composition of the  $\alpha$ -matrix (site 1) and that of the Al-Mn intermetallics (site 2) was confirmed with the EDS analysis. In the case of the treated surface, the formed layer after its immersion in HF for 48 h presented evident roughness caused by the treatment itself, and the composition of such layer (site 3) was correlated with the MgF<sub>2</sub> phase, as reported by Da Conceicao *et al.* (2010).

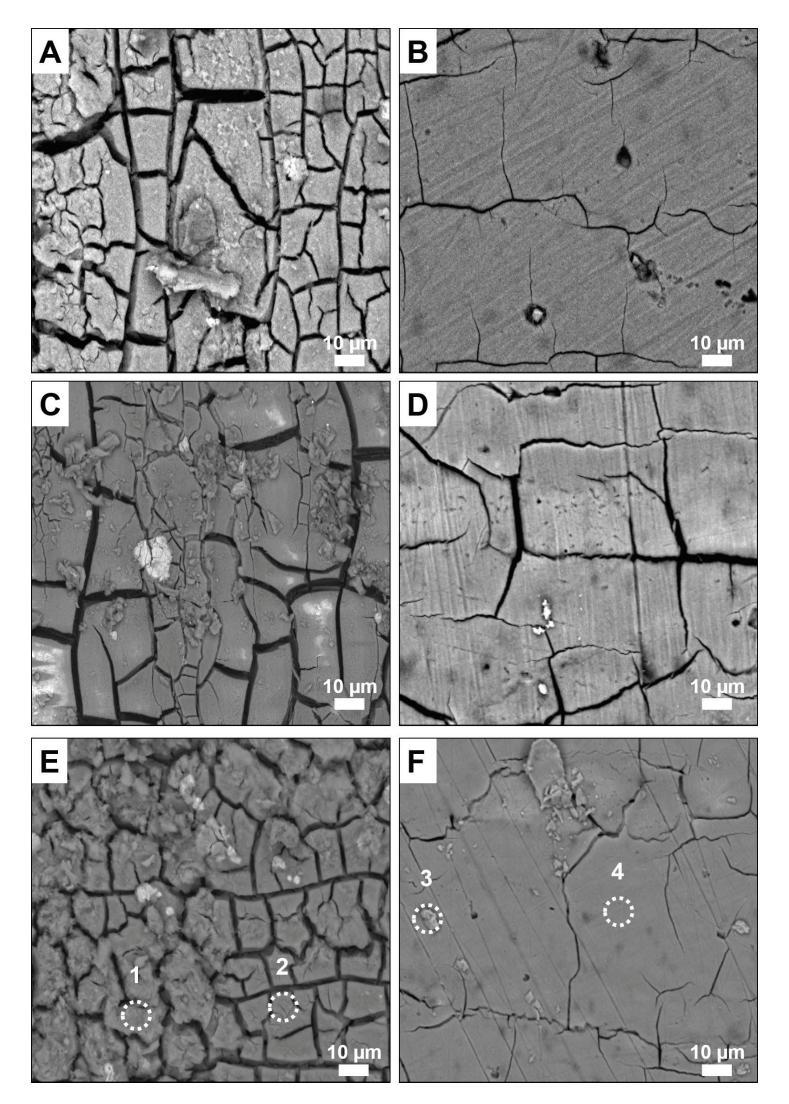
FIGURE 2. SEM images of the surface of AZ31 immersed in artificial saliva for: (A) 7 days, bare; (B) 7 days, HF-treated; (C) 14 days, bare (D) 14 days, HF-treated; (E) 28 days, bare; (F) 28 days, HF-treated.

The SEM images of the surfaces (bare and HF-treated) after immersion tests for 7, 14, and 28 days are displayed in Fig. 2. In general, the layer on the bare surface of AZ31 (Figs. 2A, 2C,

and 2E) was very cracked and presented several products/deposits on it, whereas on the HF-treated surface (Figs. 2B, 2D, and 2F) such layer was less cracked and with less deposits on it. After exposure to artificial saliva for 28 days, the corrosion layers formed on the AZ31 surfaces (Figs. 2E and 2F) were analyzed with EDS, and the acquired results are presented in Table 2. On the AZ31 bare surface (Fig. 2E), the corrosion product (site 1) has a high weight percentage of oxygen, reaching the 70% of the total quantification, suggesting that the oxygen may be related to oxides/hydroxides, with the presence of P and Ca. Meanwhile, on the cracked layer (site 2), O, P, and Ca are the elements with a higher percentage, which fact may be attributed to the deposited layer of the calcium phosphate phase. The products/deposits on the HF-treated surface (Fig. 2F, site 3) had oxygen and carbon as the elements with higher weight percentage, whereas the surface layer (site 4) is composed by the F element, having about 50 % quantification value, as a part of the MgF<sub>2</sub> layer. As additional elements, C, Ca y P were also present. Figure 3 shows the surface of the bare AZ31 after corrosion products removal. It can be observed that the corrosion damage caused deep cavities with different size, in the vicinity of the

Al-Mn intermetallic particles, which served as cathodes and maintained on the surface. The attack on the bare sample was more pronounced than on the treated one.

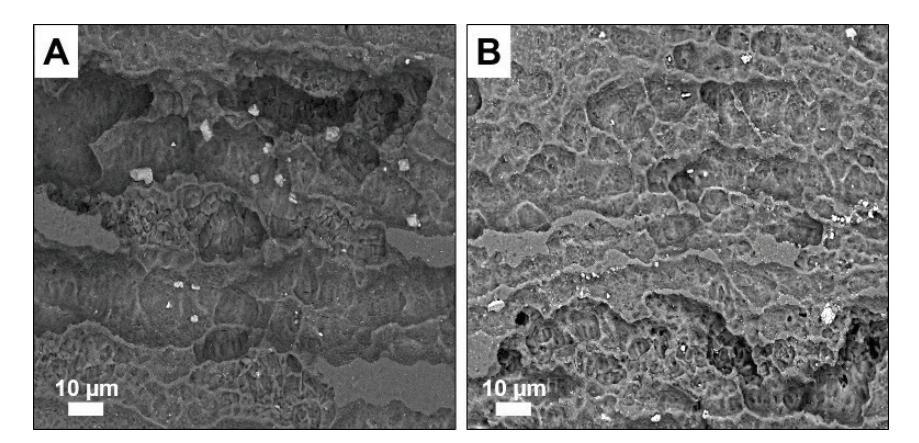
FIGURE 3. SEM images of the AZ31 surface after corrosion products removal: (A) bare, and (B) with HF-treatment.

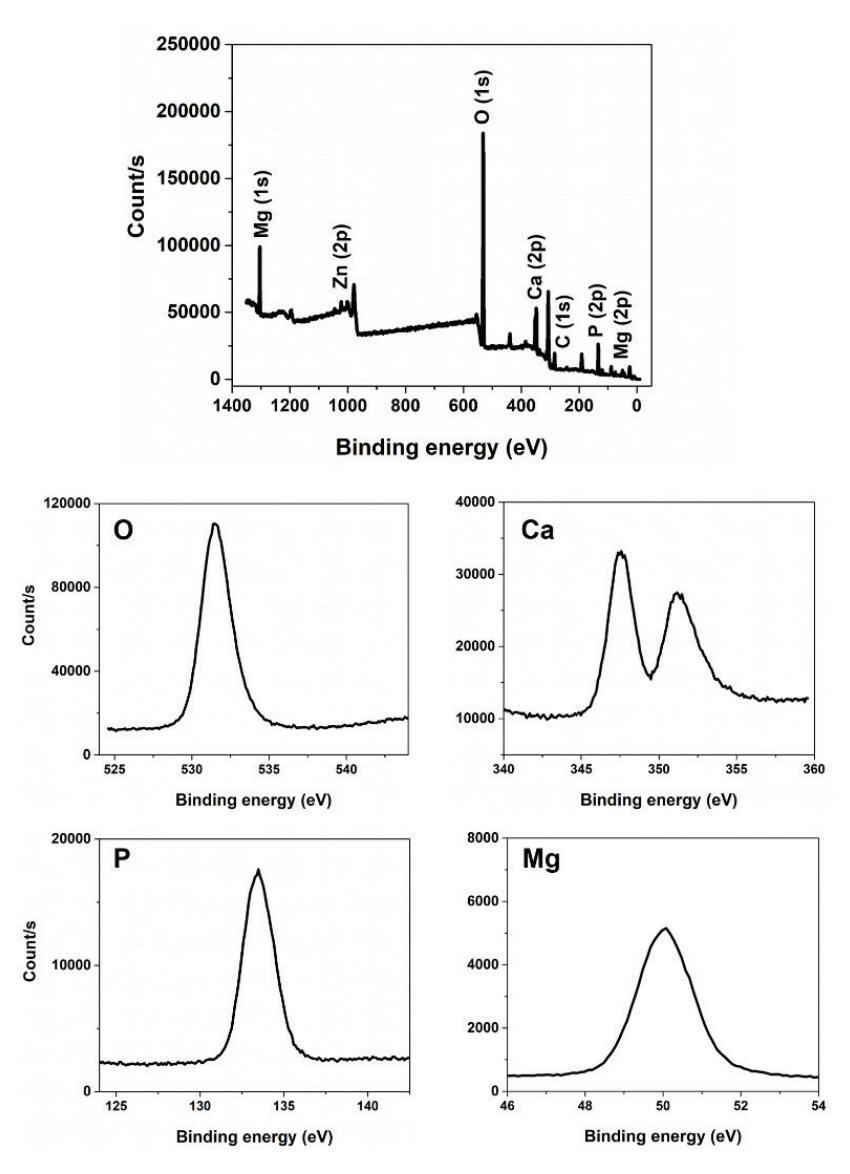
FIGURE 4. XPS full spectrum and high-resolution spectra of the elements of interest observed on the bare surface of AZ31 after immersion for 28 days in artificial saliva.

In order to confirm the phases formed on the AZ31 surfaces (bare and HF-treated), XPS analysis was performed on the samples exposed to artificial saliva for 28 days. The full XPS spectrum (Fig. 4) of the bare surface revealed peaks of Mg, Zn, O, Ca, C and P, whereas the HF-treated surface (Fig. 5) displayed peaks of Mg, F, O, C and P. The value of the binding energies of Mg showed one peak centered approximately: at 50.5 eV for the bare surface, and at

51.5 eV for the HF-treated surface, which are associated to Mg(OH)<sub>2</sub> and MgCO<sub>3</sub> respectively (Moulder, *et al.*, 1992). In the case of the bare sample, it can be seen that the spectrum for Ca shows two peaks centered at 347.9 eV and 351.5 eV approximately, whereas the spectrum for P has one peak at 134 eV. These values are linked to the bonding between  $(PO_4)_3^-$  and Ca in the form of  $Ca_{10}(PO_4)_6(OH)_2$  (Mena-Morcillo *et al.*, 2018). On the other hand, for the HF-treated sample, the spectrum for F showed a peak positioned at about 685.4 eV, which is related to the MgF<sub>2</sub> phase (Moulder *et al.*, 1992). The XPS results showed to be well correlated with the EDS quantification values obtained in the previous section (Table 2).

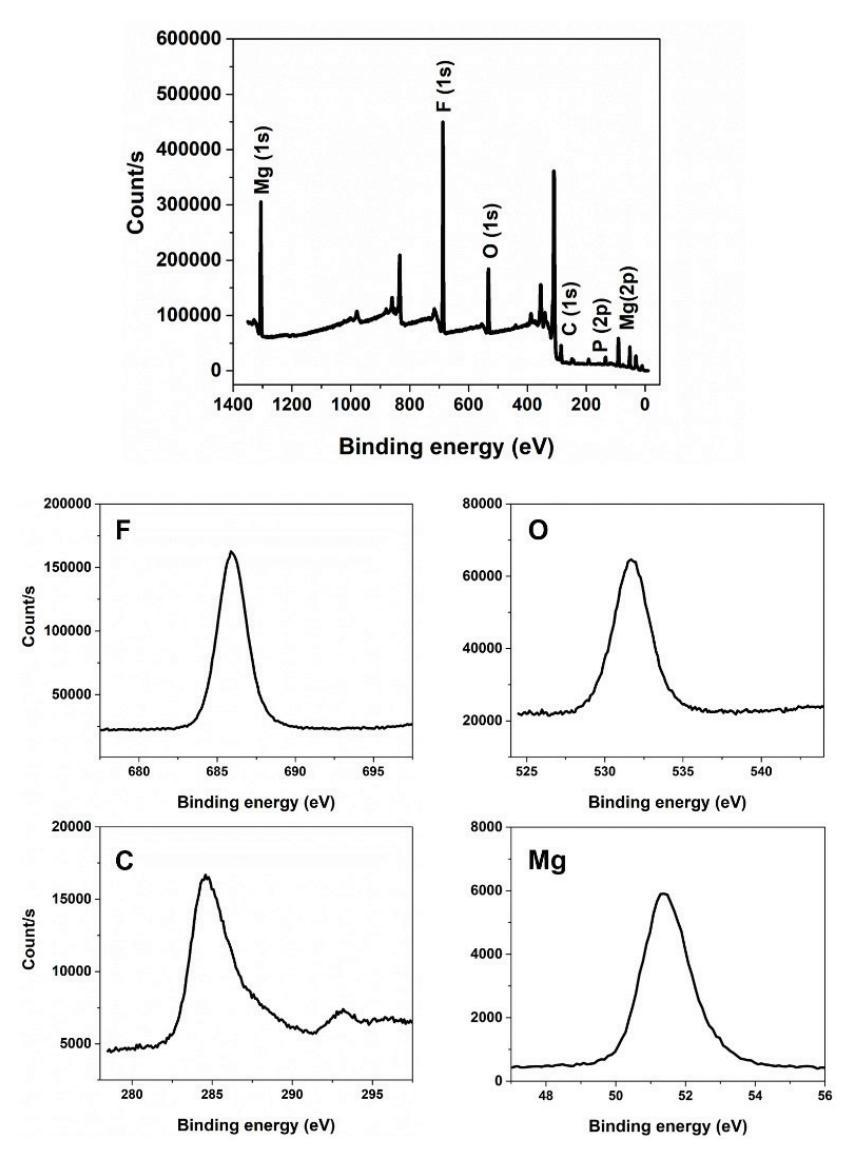
FIGURE 5. XPS full spectrum and high-resolution spectra of the elements of interest observed on the HF-treated surface of AZ31 exposed for 28 days in artificial saliva.

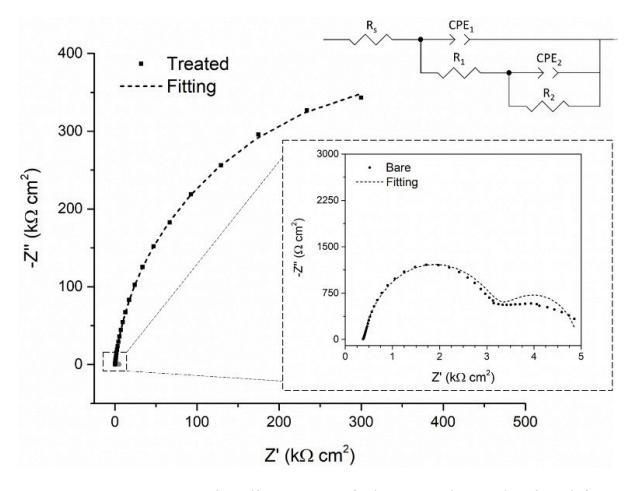
FIGURE 6. Nyquist diagrams of the EIS data obtained for the bare and treated surfaces of AZ31 alloy, after 30 min of immersion in artificial saliva. The dashed lines correspond to the equivalent electrical circuit fitting.

Figure 6 illustrates the EIS Nyquist diagrams performed for both bare and HF-treated AZ31 surfaces, after their exposure to artificial saliva for 30 min. The data were fitted to an equivalent electrical circuit (Fig. 6), the parameters of which are presented in Table 3. According to Murray *et al.* (1988),  $R_s$  is associated with the resistance of the solutions,  $R_1$  with the initial corrosion stage,  $R_2$  with the discharge of intermediate adsorbed species. These resistive parameters could also be related to local changes occurring close to anodic and cathodic regions, such as the presence of H<sub>2</sub> bubbles (Curioni *et al.*, 2015). The capacitive elements

$CPE_1$ , and  $CPE_2$  represent the capacitance of the corrosion product film and the capacitance formed by the double layer at the metal/electrolyte interface, respectively (Delgado *et al.*, 2017).

where  $j_{corr}$  is the corrosion current density, *B* is the Stern-Geary constant, and  $R_p$  is the polarisation resistance value. Thus, if the  $R_p$  value increases, the  $j_{corr}$  decreases, which leads to a lower corrosion rate, as stated by ASTM G102-89 (2015). The  $R_p$ value for the bare surface was 4.34 k $\Omega$  cm<sup>2</sup>, while the  $R_p$  for the treated surface was 815.65 k $\Omega$  cm<sup>2</sup>. The above indicates that the  $j_{corr}$  value (related to the corrosion rate) of the treated surface should be

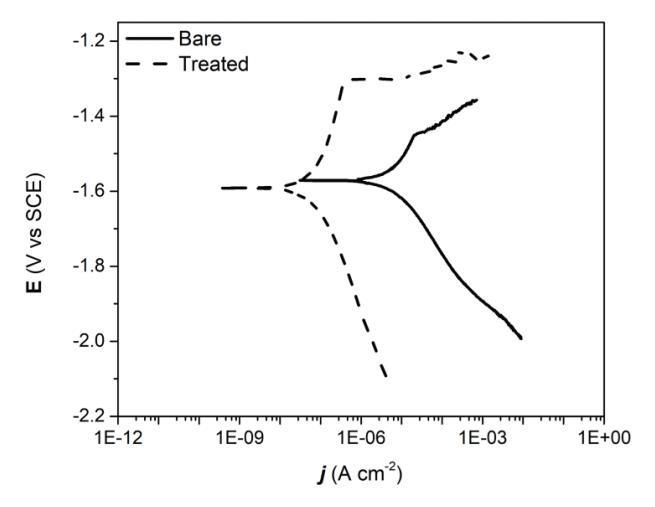
FIGURE 7. Potentiodynamic polarisation curves (PDP) performed on AZ31 alloy, on bare surface and HF-treated, after 30 min of immersion in artificial saliva.

Figure 7 displays the curves acquired from the potentiodynamic polarisation (PDP) applied on the surface of AZ31 in its different conditions (bare and treated), after 30 min of exposure to artificial saliva. The cathodic curve of the bare surface indicates that the reduction of oxygen is more intense than that corresponding to the HF-treated surface: both facts indicate that this process occurs with a greater difficulty on the HF-treated surface, because of the formed MgF<sub>2</sub> layer. In the anodic curves of AZ31 oxidation it can be observed that the current density values of the bare surface are about two orders higher than those of the HF-treated surface, which is also an indication of a greater corrosion resistance, provided by the protective layer of MgF<sub>2</sub> formed on the HF-treated AZ31 surface. The Tafel extrapolation method was used to estimate the corrosion potential  $(E_{corr})$  and the corrosion current density  $(j_{corr})$ . Additionally, the  $j_{corr}$  value was employed to calculate the instantaneous corrosion rate (CR) of both the bare and treated surface, according to the following Eq. (2) provided by the ASTM G102-89 (2015):

where K is a constant  $(3.27 \times 10^{-3} \text{ mm g/}\mu\text{A cm year})$ ,  $j_{corr}$  is the corrosion current density ( $\mu\text{A}\cdot\text{cm}^{-2}$ ),  $E_W$  is the equivalent weight of AZ31 (12.2, dimensionless),  $\rho$  is the density of AZ31 (1.74 g·cm<sup>-3</sup>). Table 4 shows the estimated values of  $E_{corr}$  and  $j_{corr}$ , as well as the calculated *CR* values. It can be noted that the corrosion rate of the AZ31 HF-treated surface was in fact two orders of magnitude lower than the *CR* of the bare surface, as predicted with the results of EIS.
